Noise Levels at LT-1
~ 420 feet from Center of Columbus Parkway, East of Turnberry Way Residences
Thursday, April 29, 2010

4.12-3

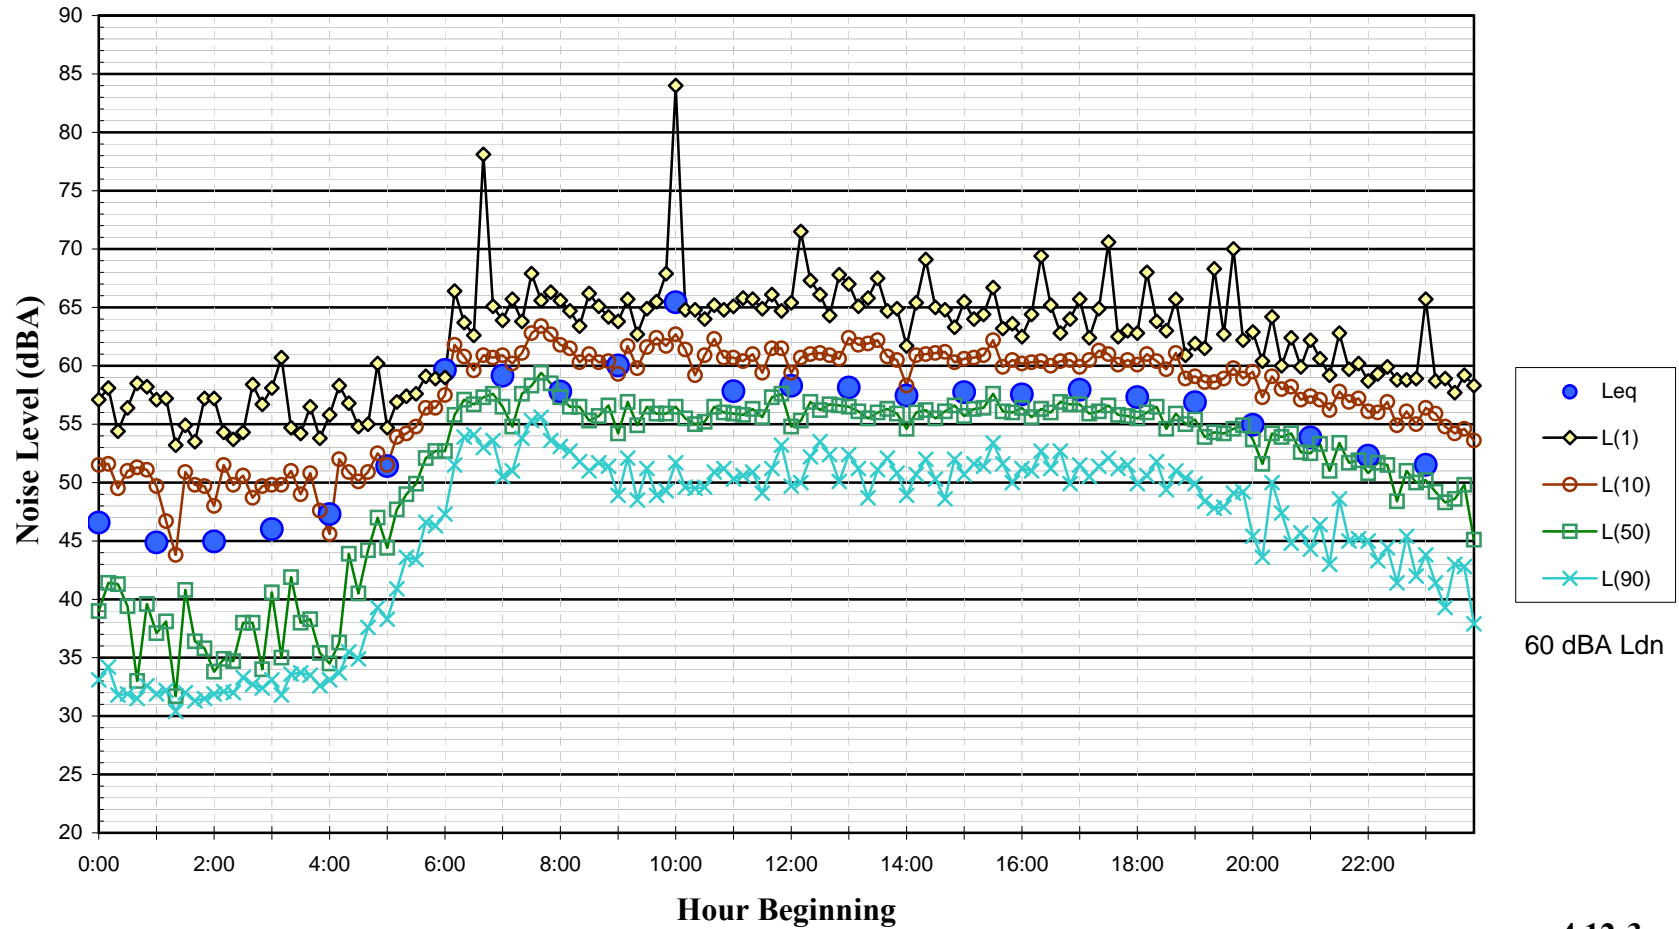
Figure 2

Noise Levels at LT-1
~ 420 feet from Center of Columbus Parkway, East of Turnberry Way Residences
Friday, April 30, 2010

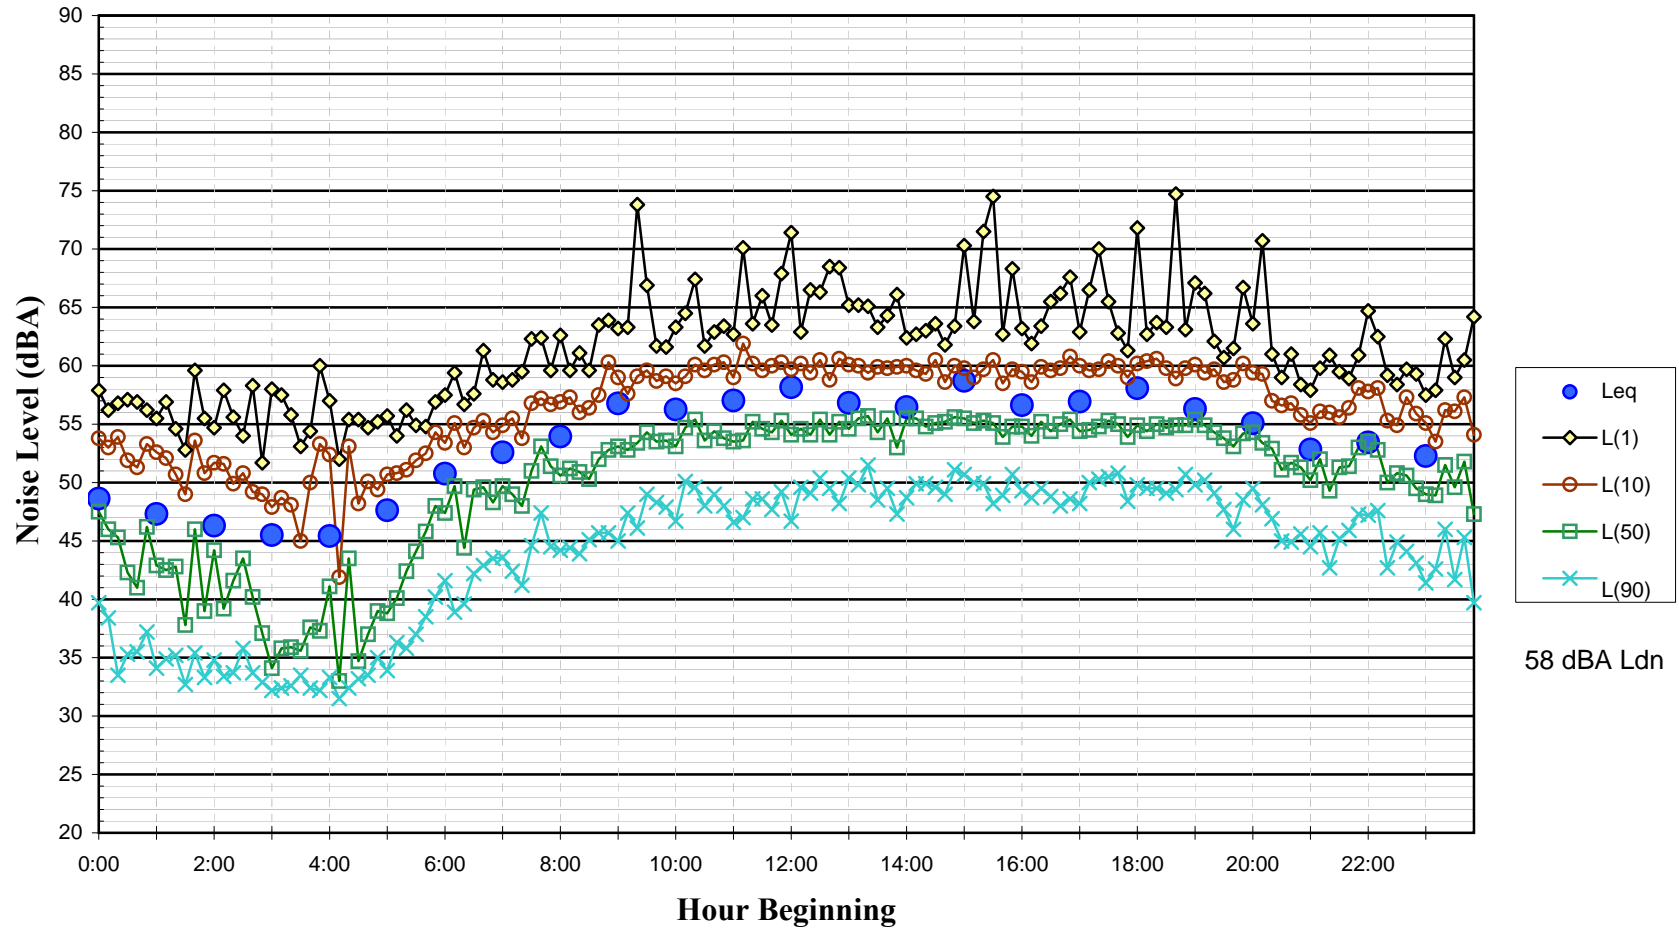
Noise Levels at LT-1
~ 420 feet from Center of Columbus Parkway, East of Turnberry Way Residences
Saturday, May 1, 2010

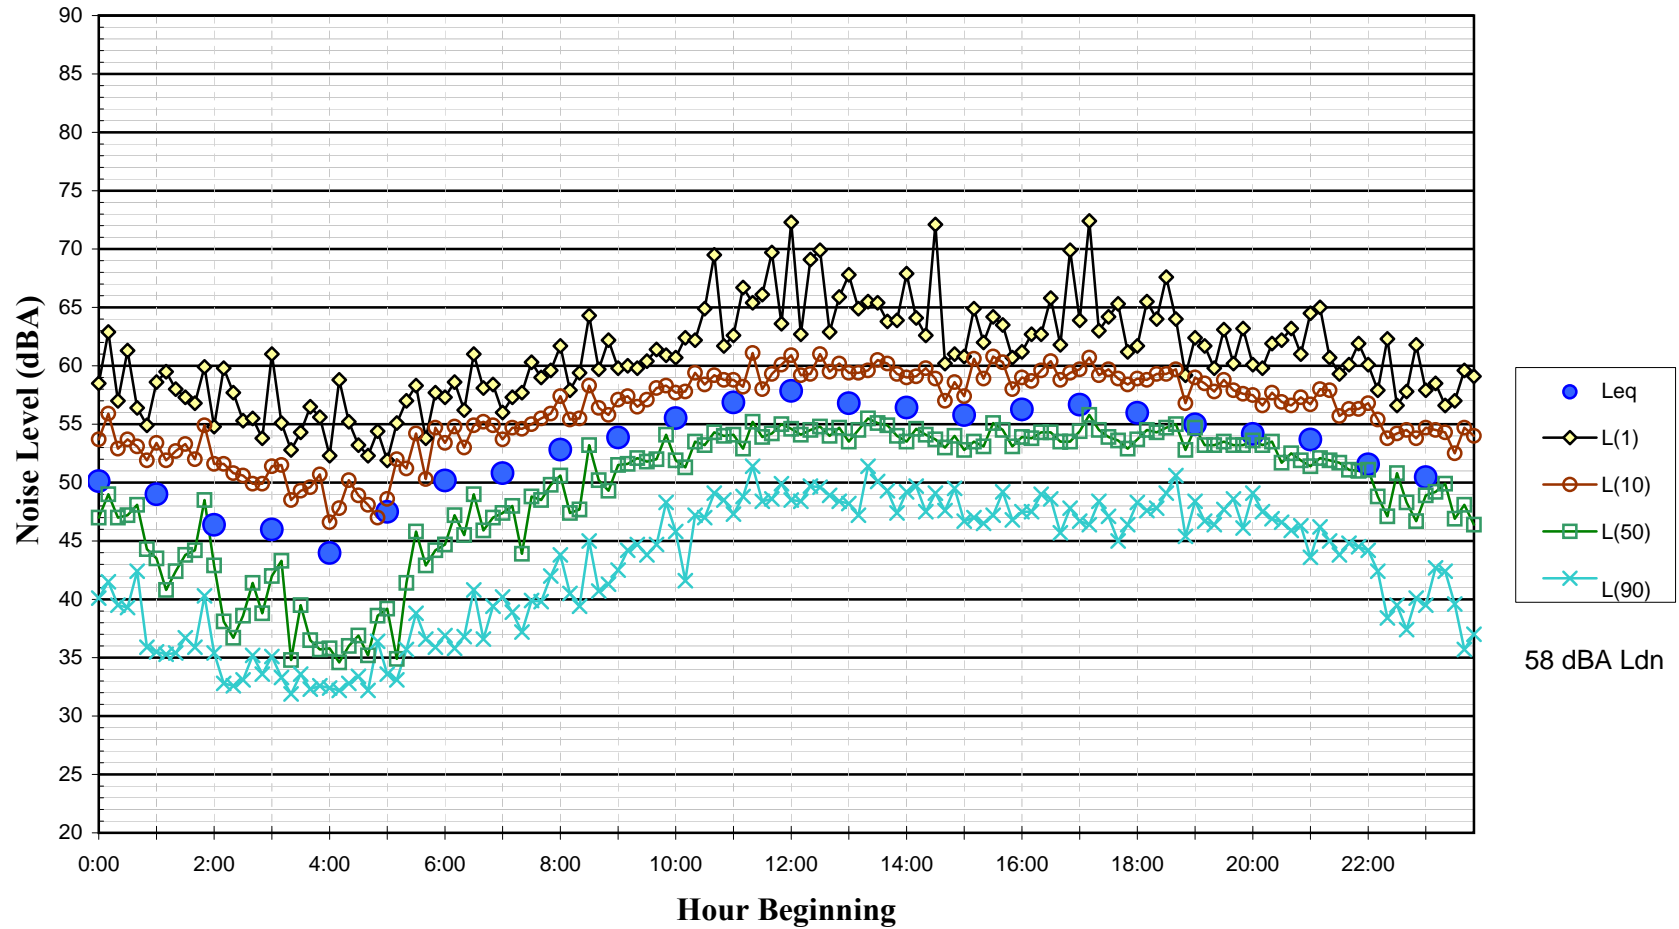
Figure 4

Noise Levels at LT-1
~ 420 feet from Center of Columbus Parkway, East of Turnberry Way Residences
Sunday, May 2, 2010

58 dBA Ldn

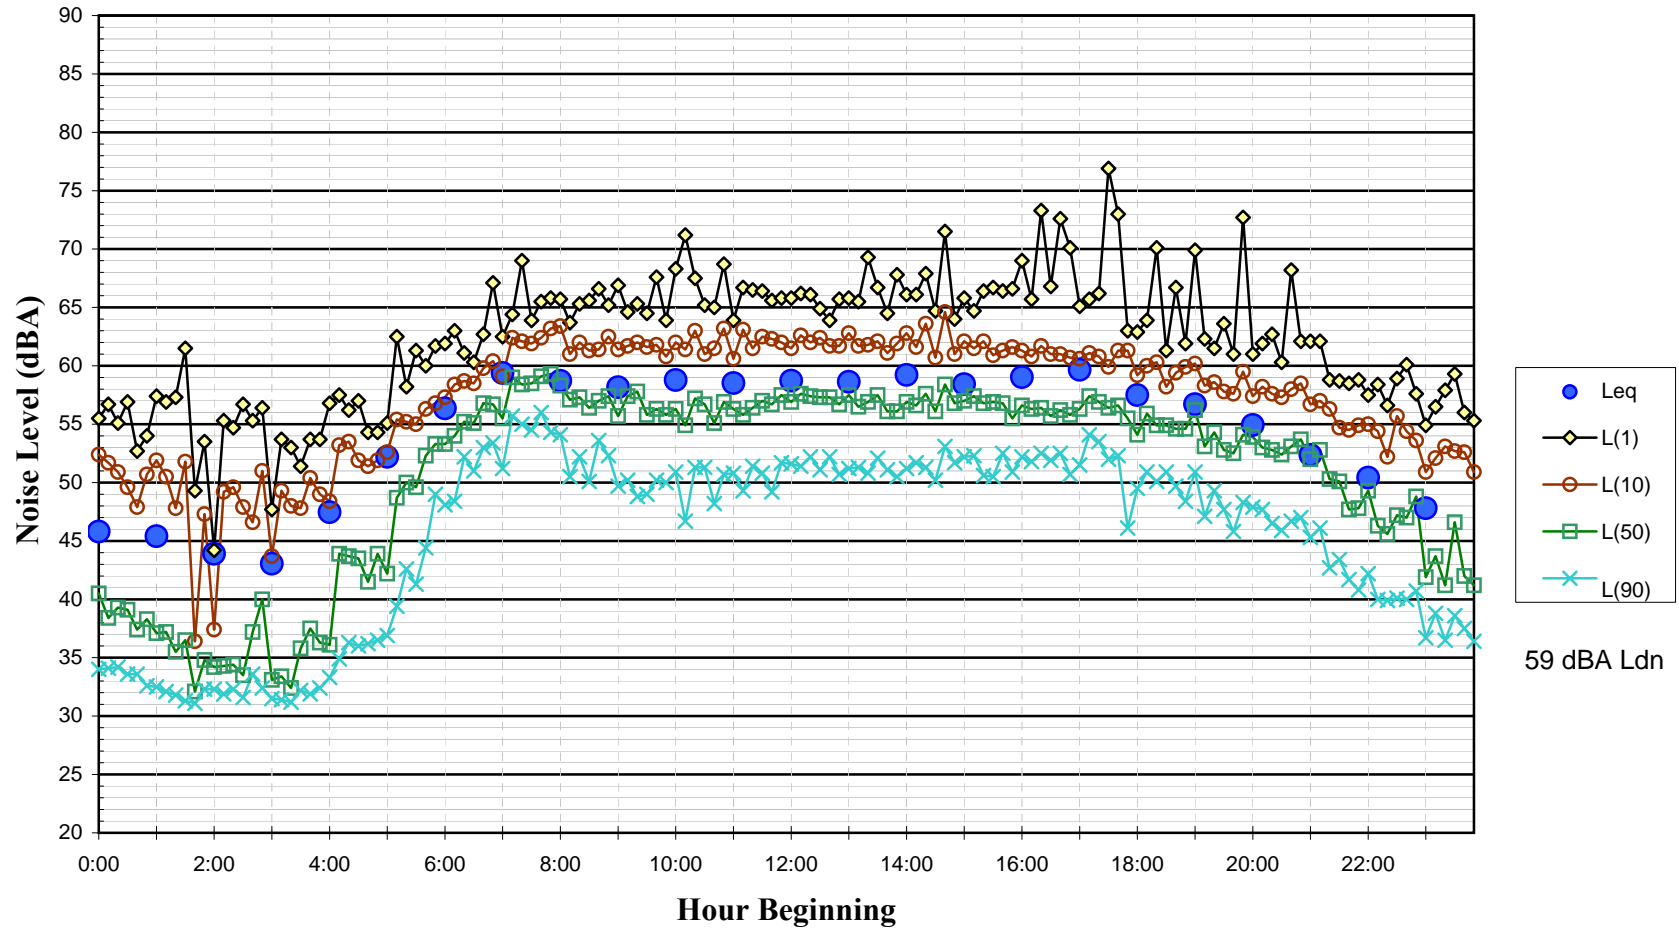
Figure 5

Noise Levels at LT-1
~ 420 feet from Center of Columbus Parkway, East of Turnberry Way Residences
Monday, May 3, 2010

59 dBA Ldn

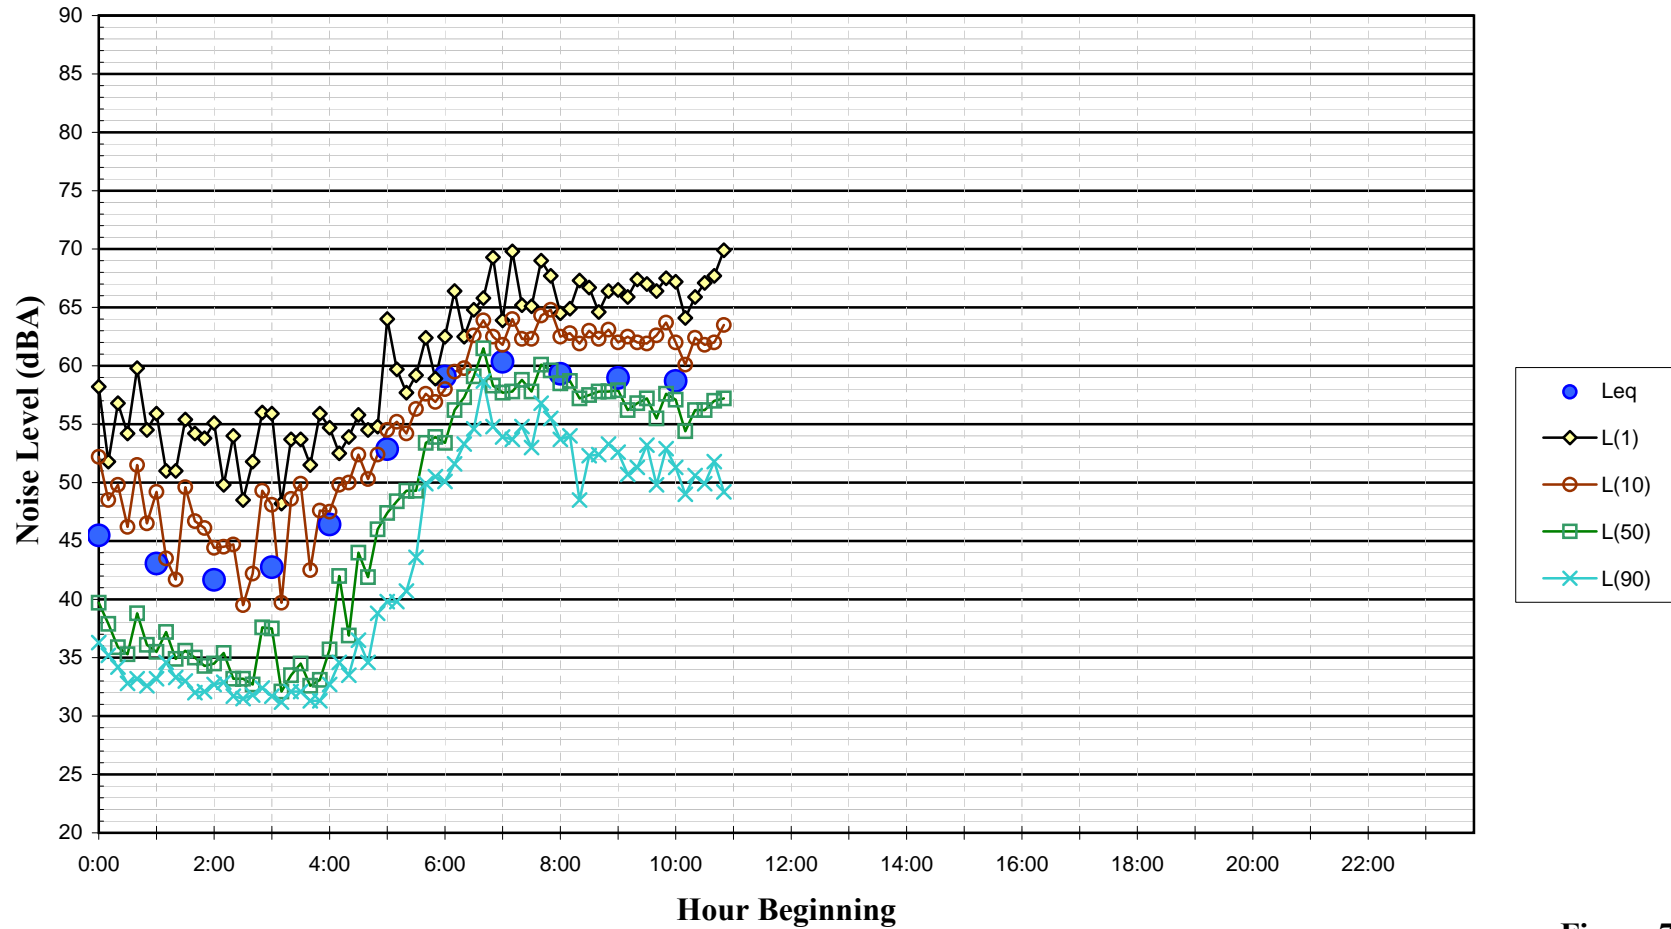
Figure 6

Noise Levels at LT-1
~ 420 feet from Center of Columbus Parkway, East of Turnberry Way Residences
Tuesday, May 4, 2010

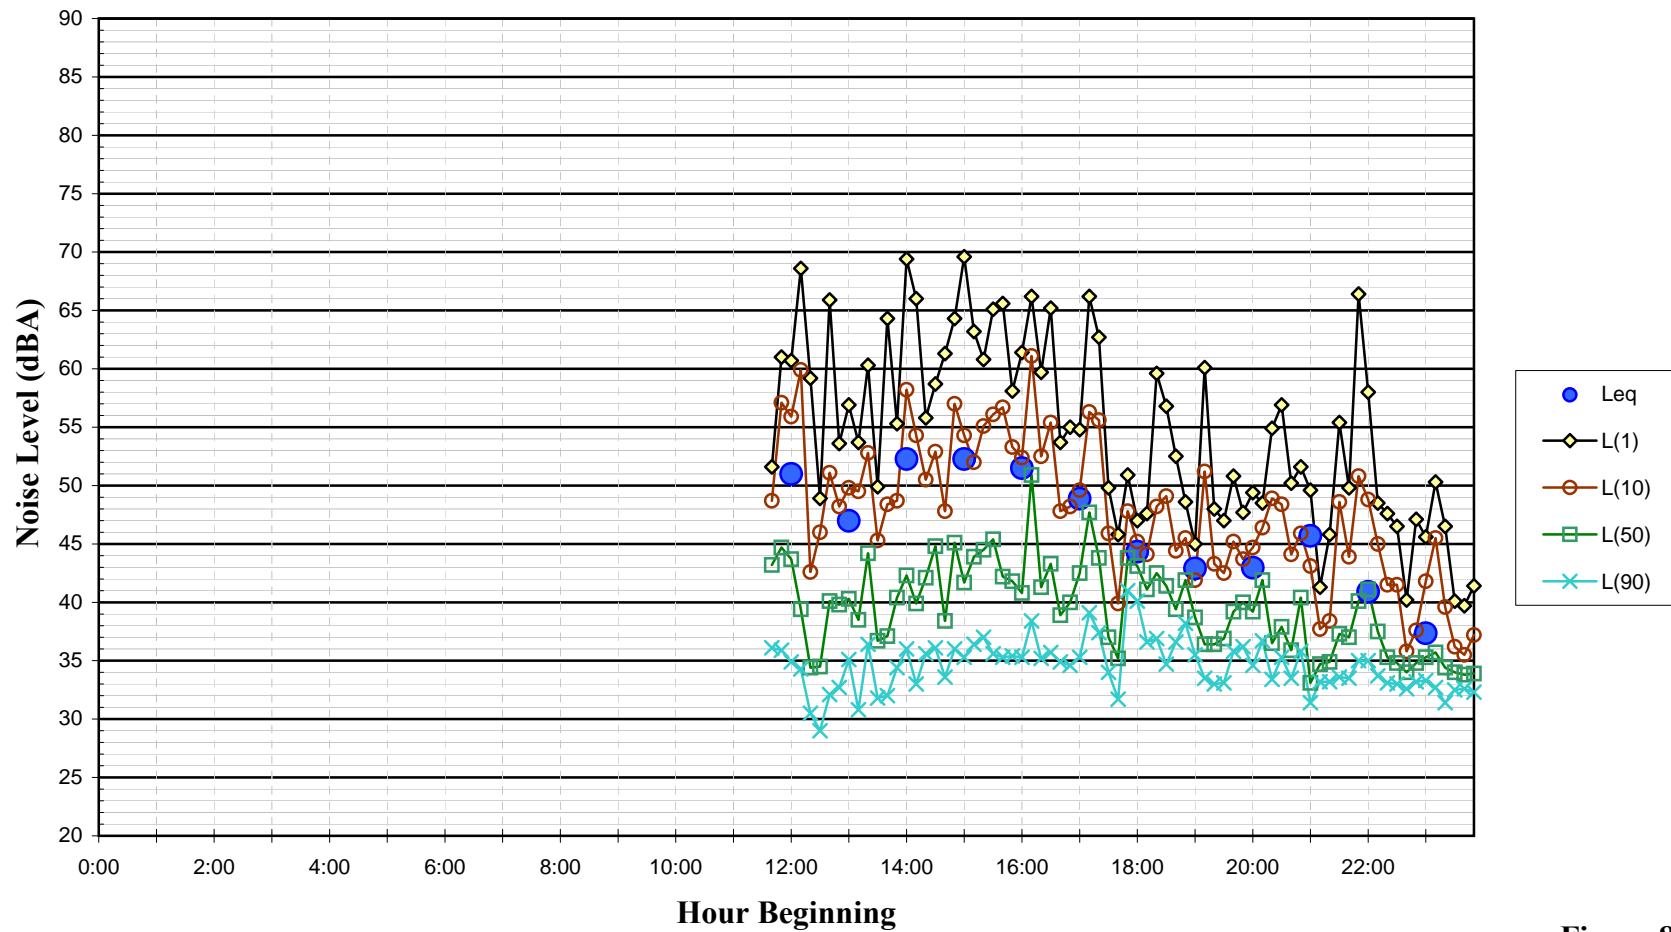
Figure 7

Noise Levels at LT-2
~ Sky Valley Lane, East of Lake Herman Quarry
Thursday, April 29, 2010

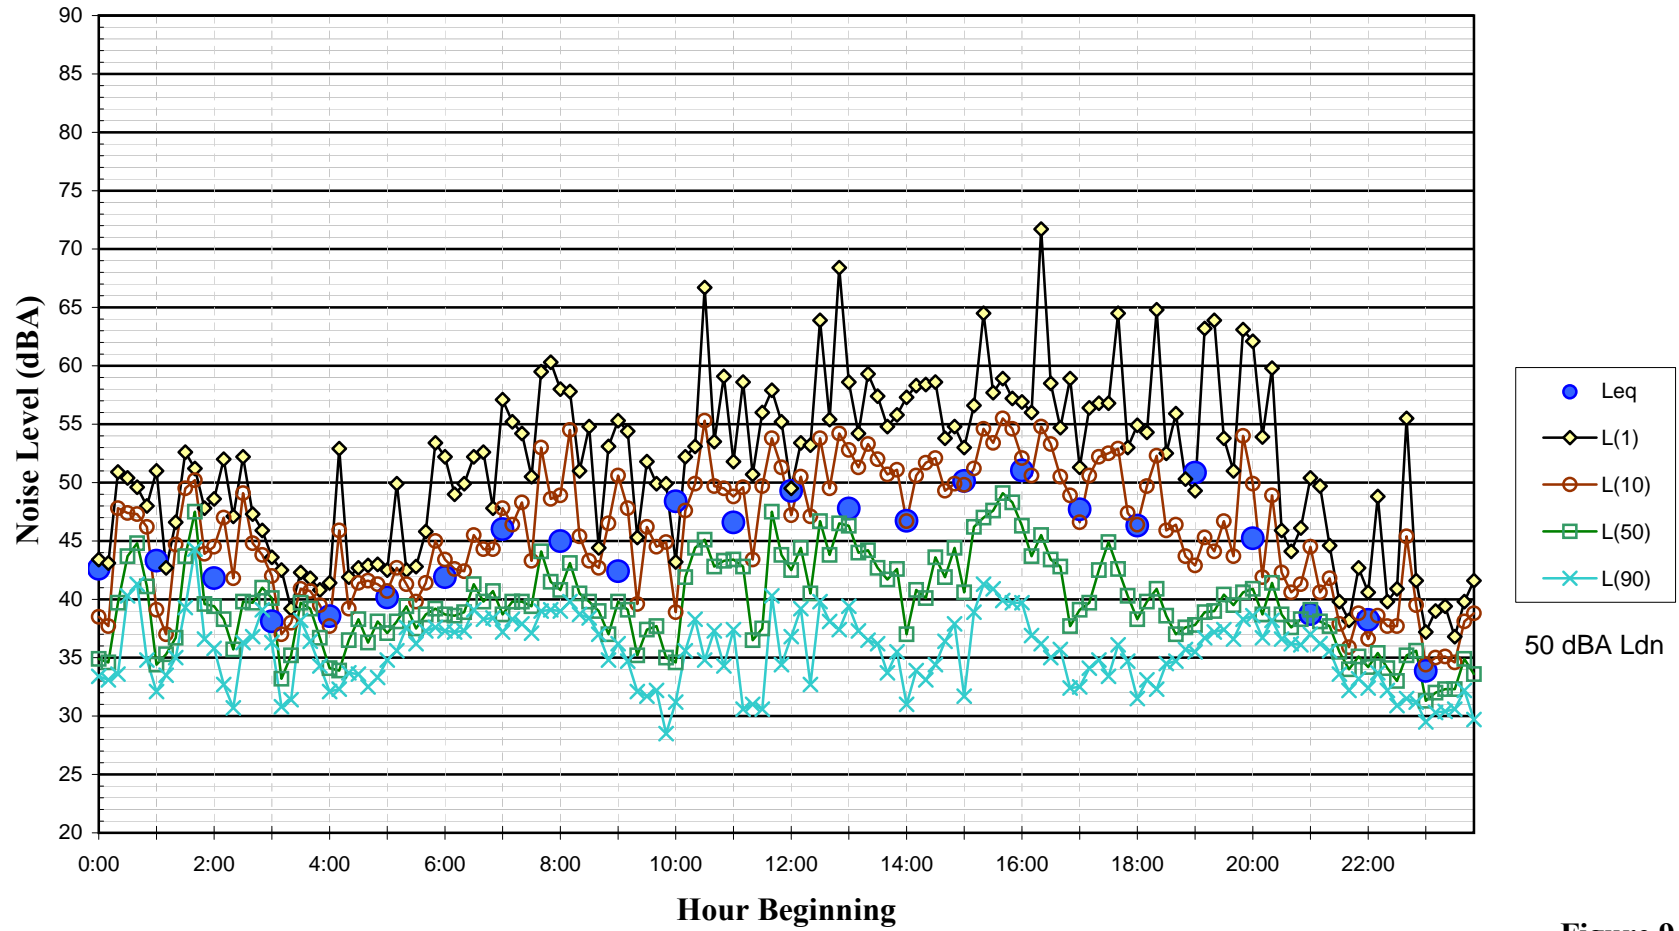
Figure 8

Noise Levels at LT-2
~ Sky Valley Lane, East of Lake Herman Quarry
Friday, April 30, 2010

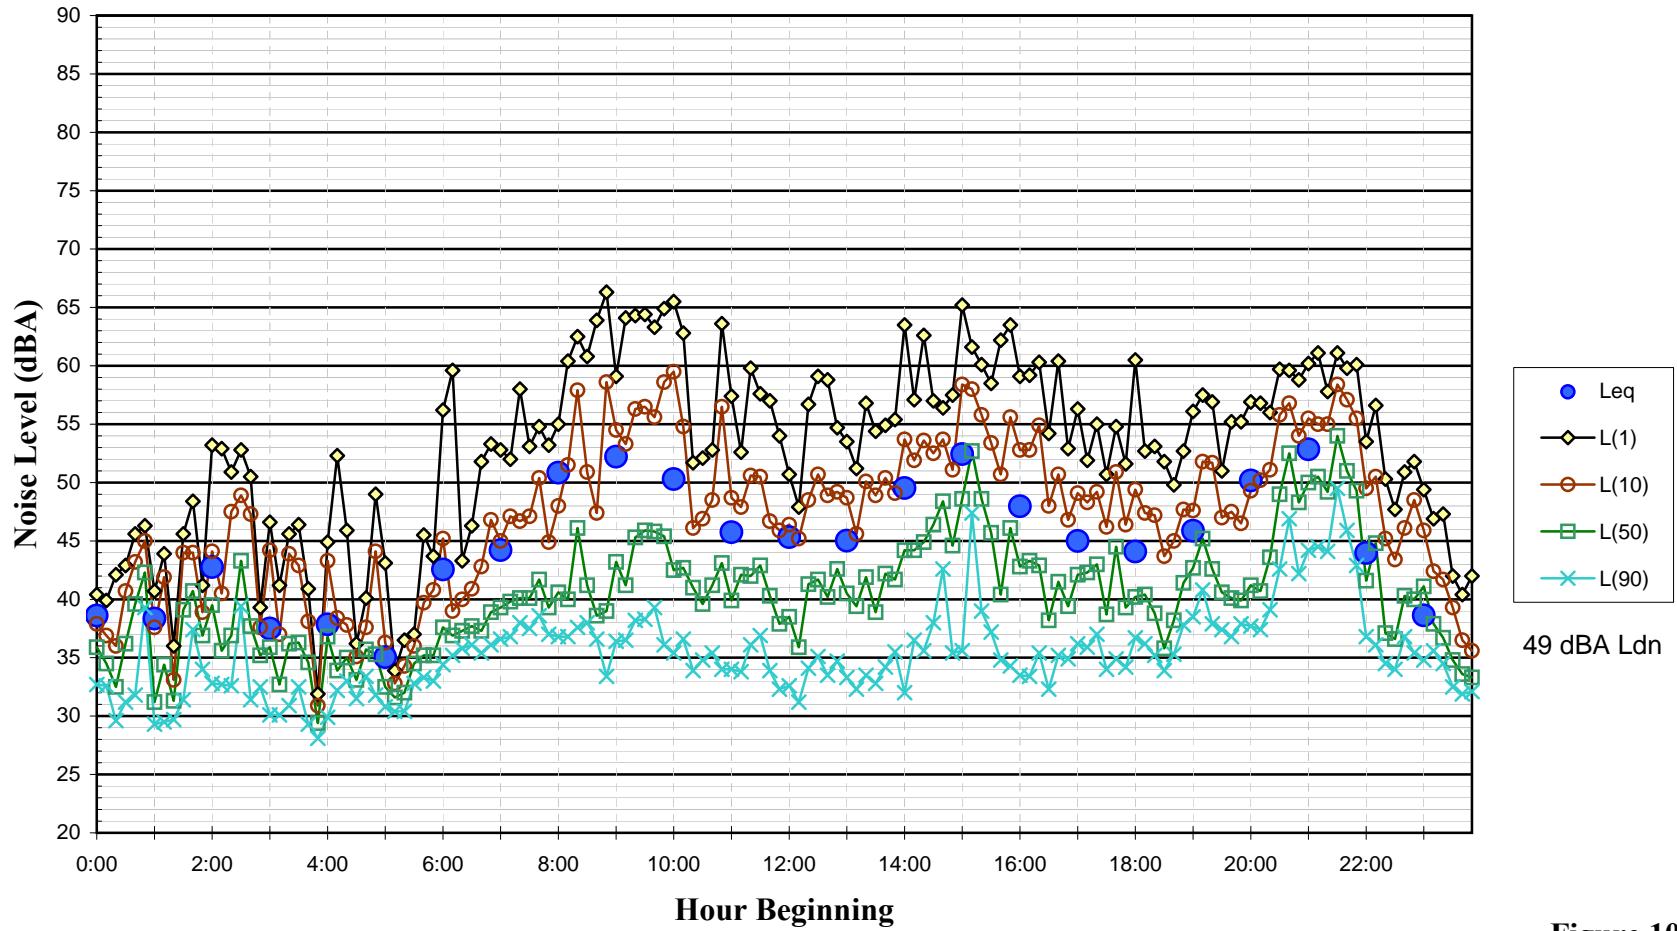
Figure 9

Noise Levels at LT-2
~ Sky Valley Lane, East of Lake Herman Quarry
Saturday, May 1, 2010

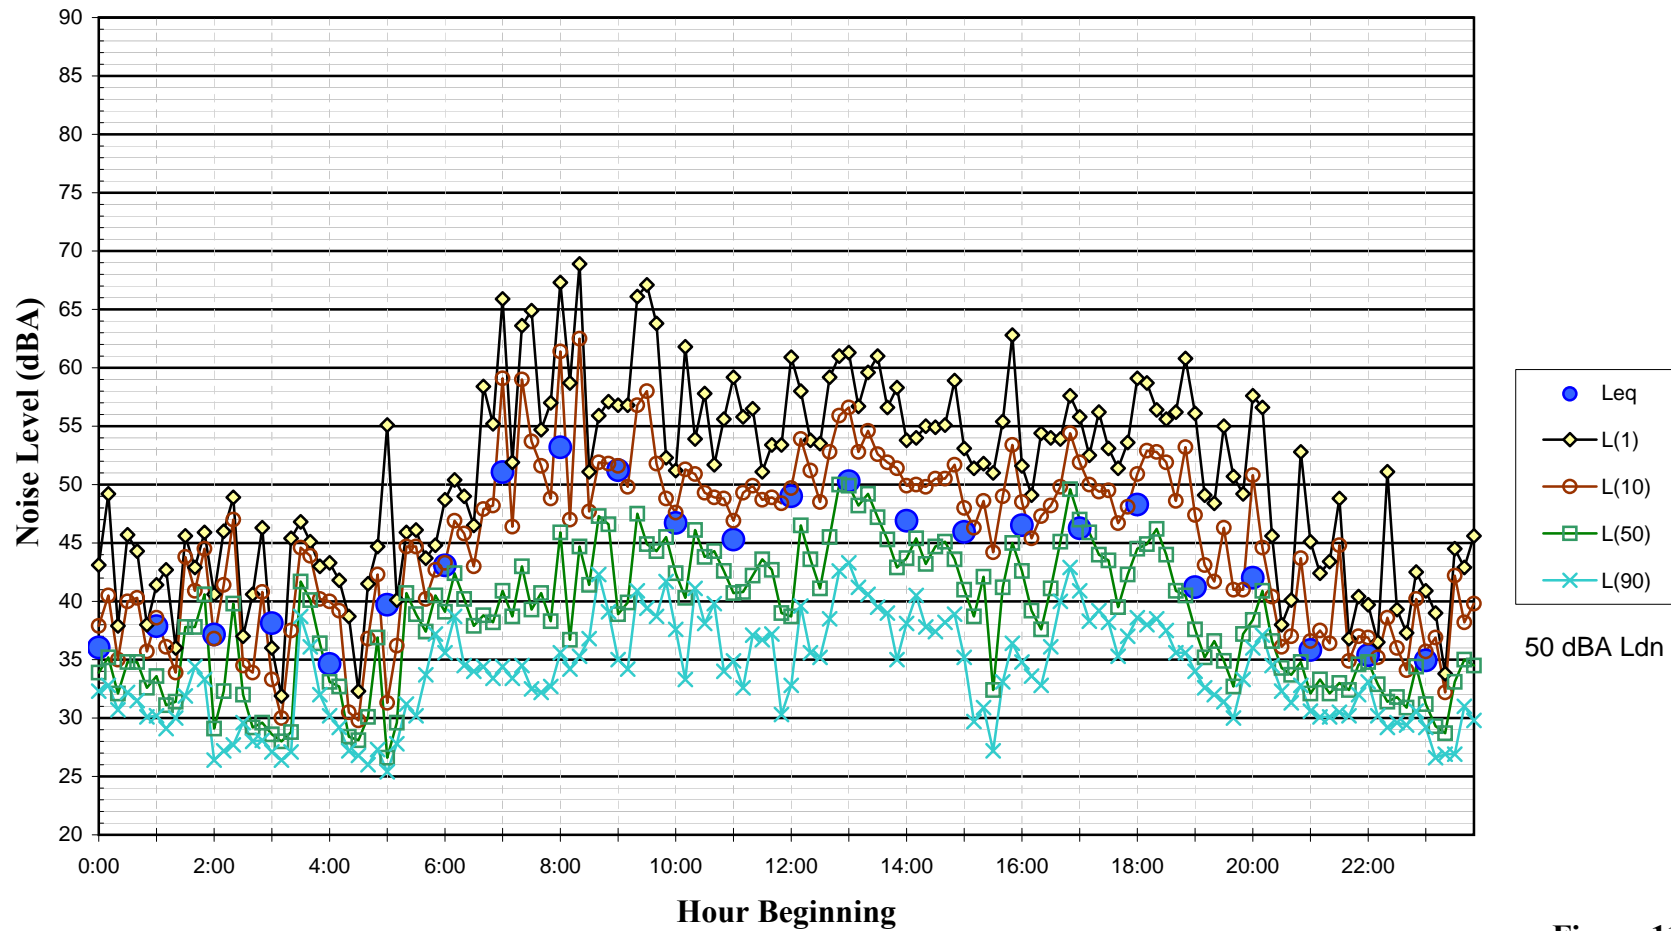
Figure 10

Noise Levels at LT-2
~ Sky Valley Lane, East of Lake Herman Quarry
Sunday, May 2, 2010

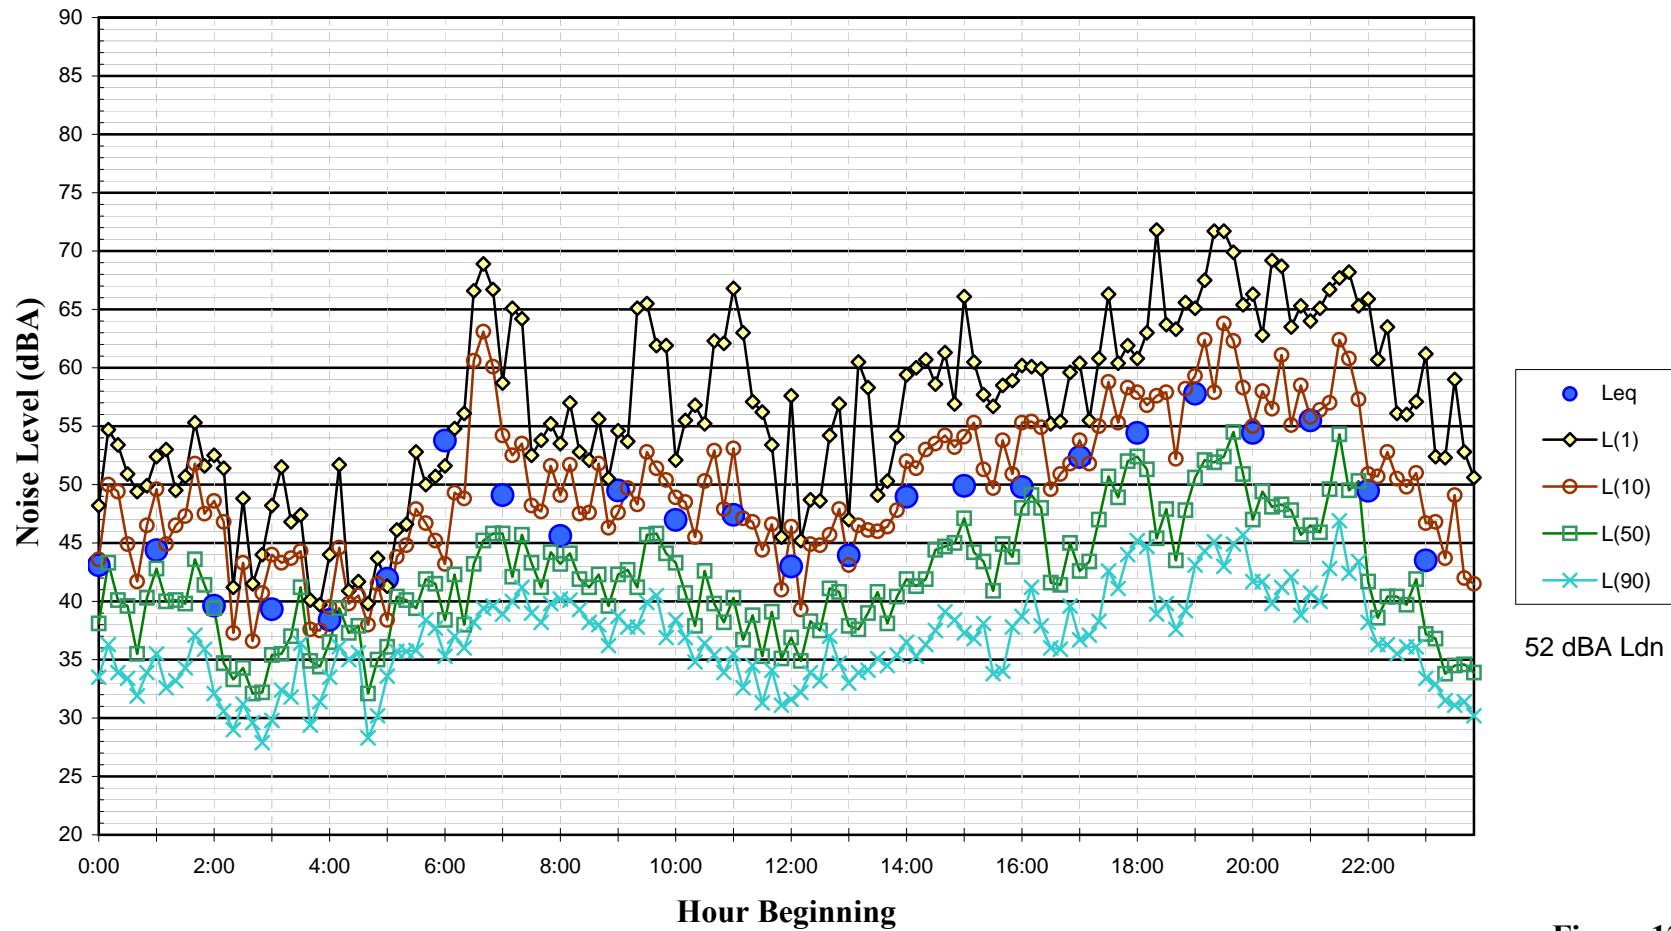
Figure 11

**Noise Levels at LT-2
~ Sky Valley Lane, East of Lake Herman Quarry
Monday, May 3, 2010**

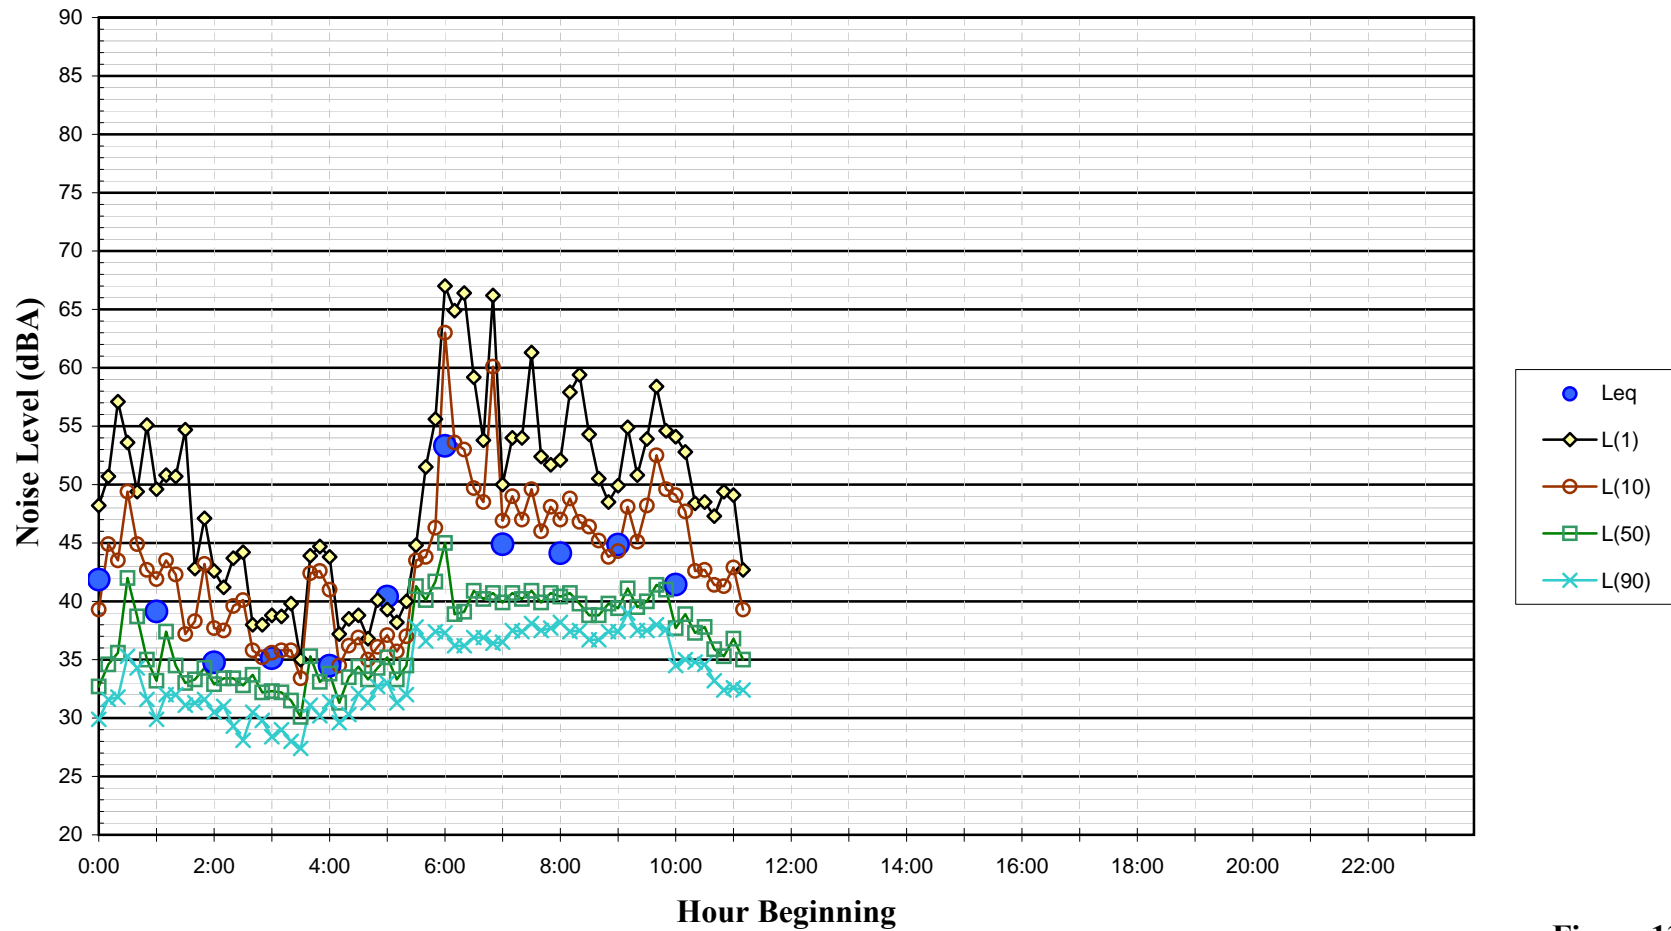
Figure 12

Noise Levels at LT-2
~ Sky Valley Lane, East of Lake Herman Quarry
Tuesday, May 4, 2010

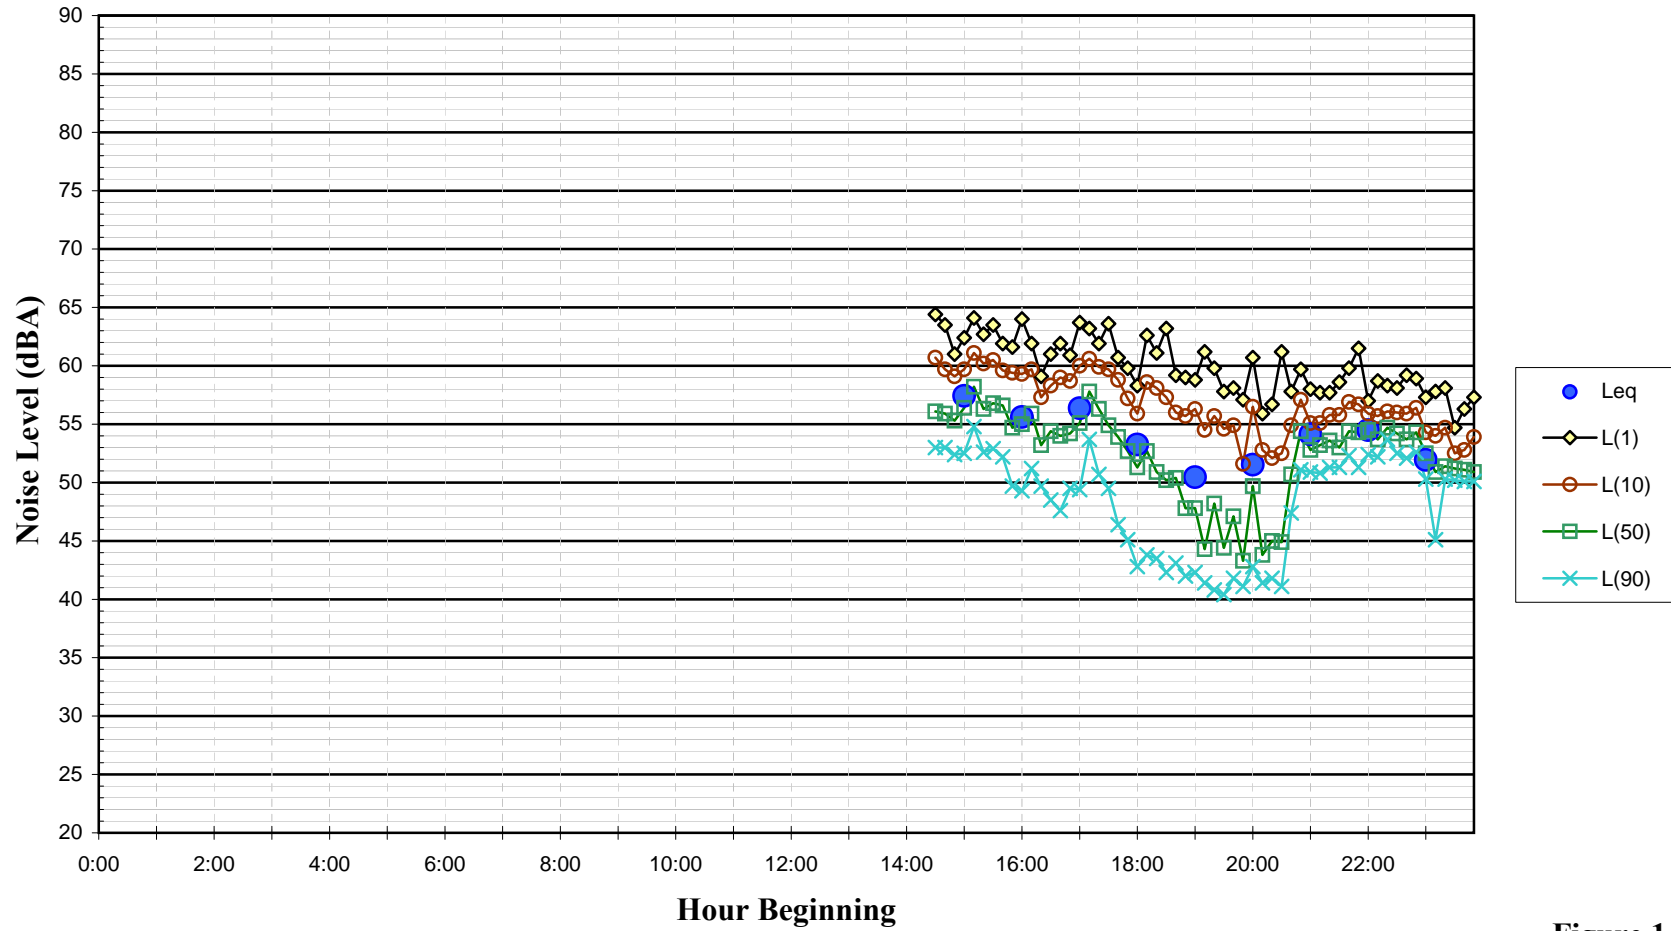
Figure 13

Noise Levels at LT-3
~ Lake Herman Quarry near Asphalt/Concrete Plants
Thursday, April 29, 2010

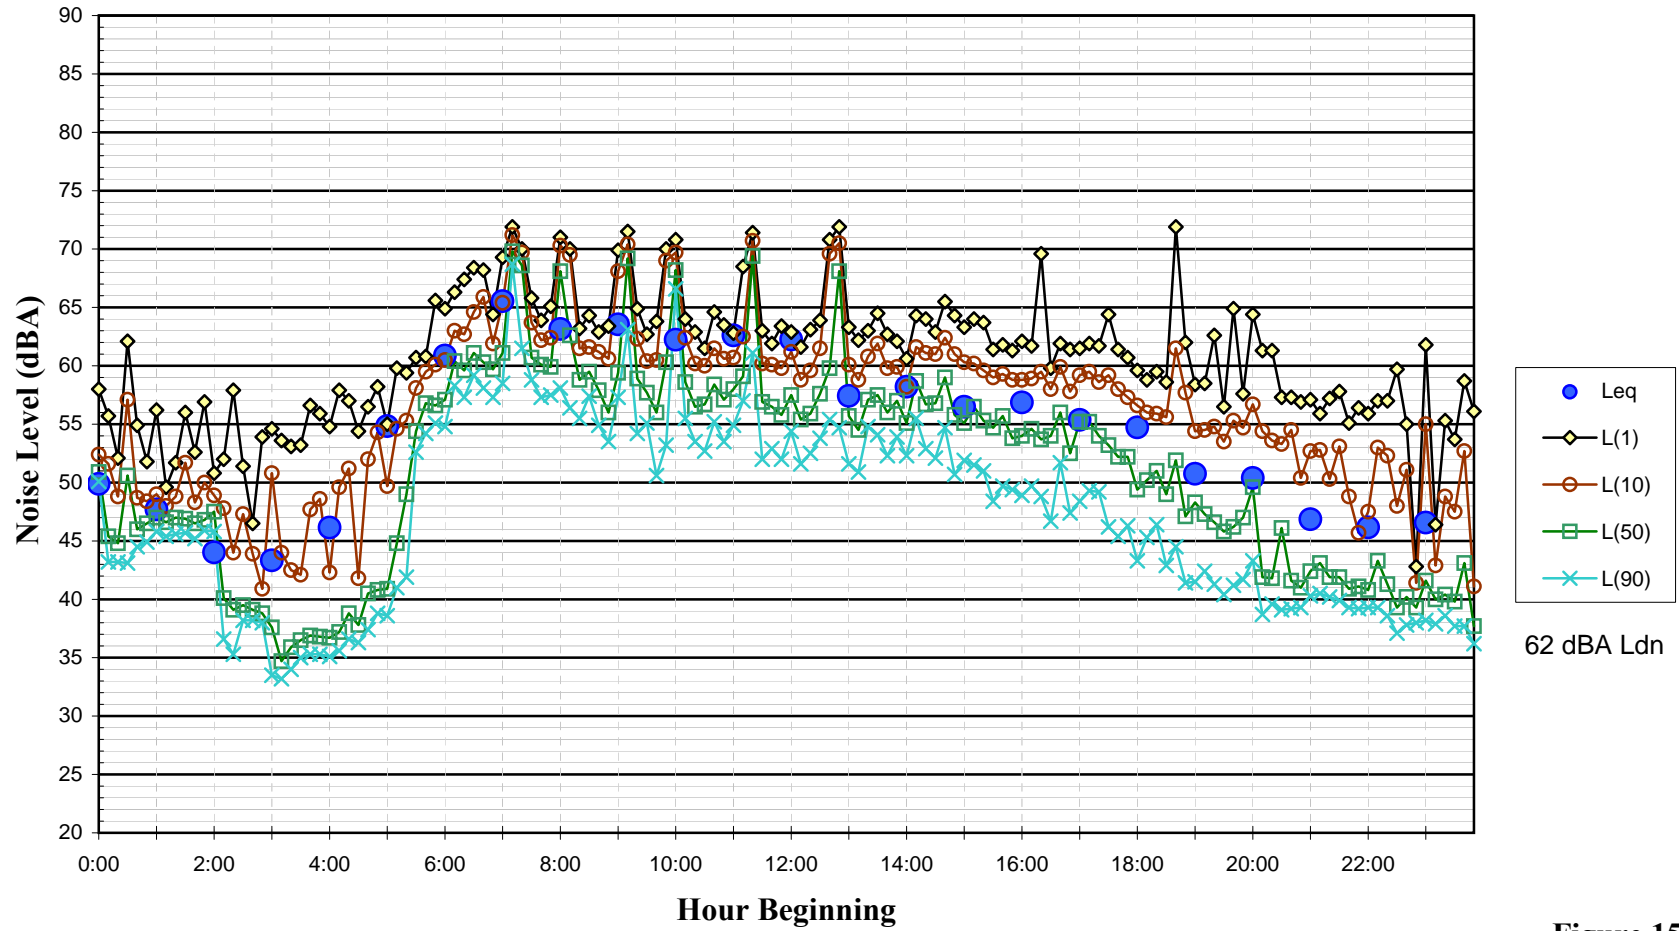
Figure 14

**Noise Levels at LT-3
~ Lake Herman Quarry near Asphalt/Concrete Plants
Friday, April 30, 2010**

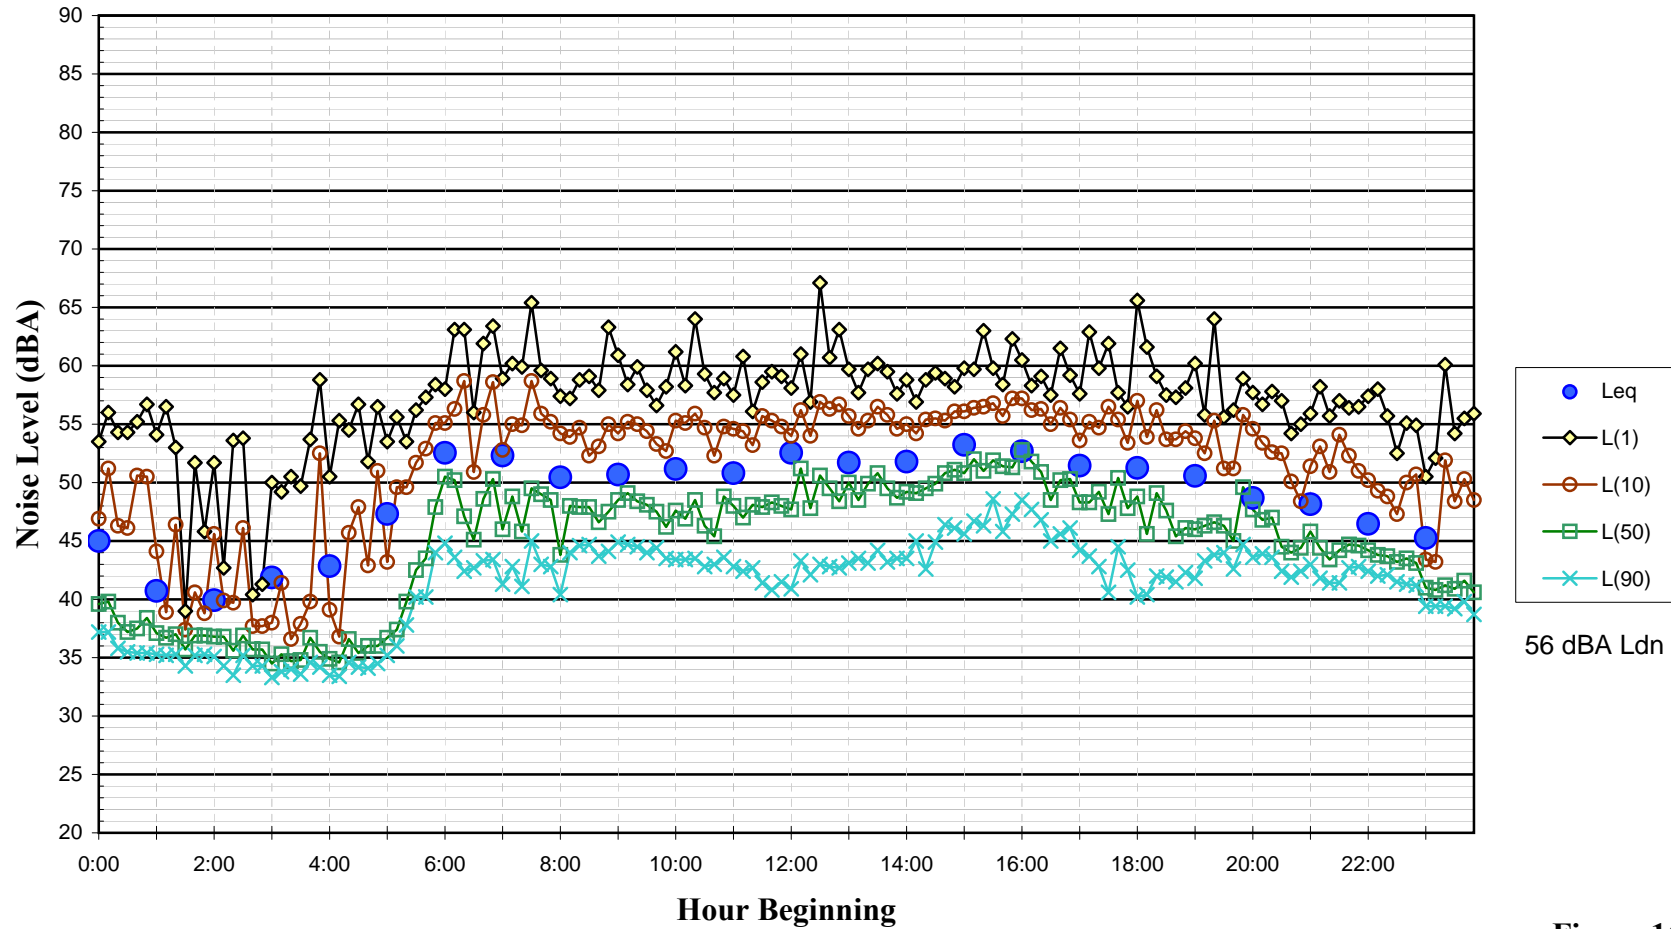
Figure 15

**Noise Levels at LT-3
~ Lake Herman Quarry near Asphalt/Concrete Plants
Saturday, May 1, 2010**

56 dBA Ldn
