Noise Levels at LT-1
~ 420 feet from Center of Columbus Parkway, East of Turnberry Way Residences
Thursday, April 29, 2010

4.12-3

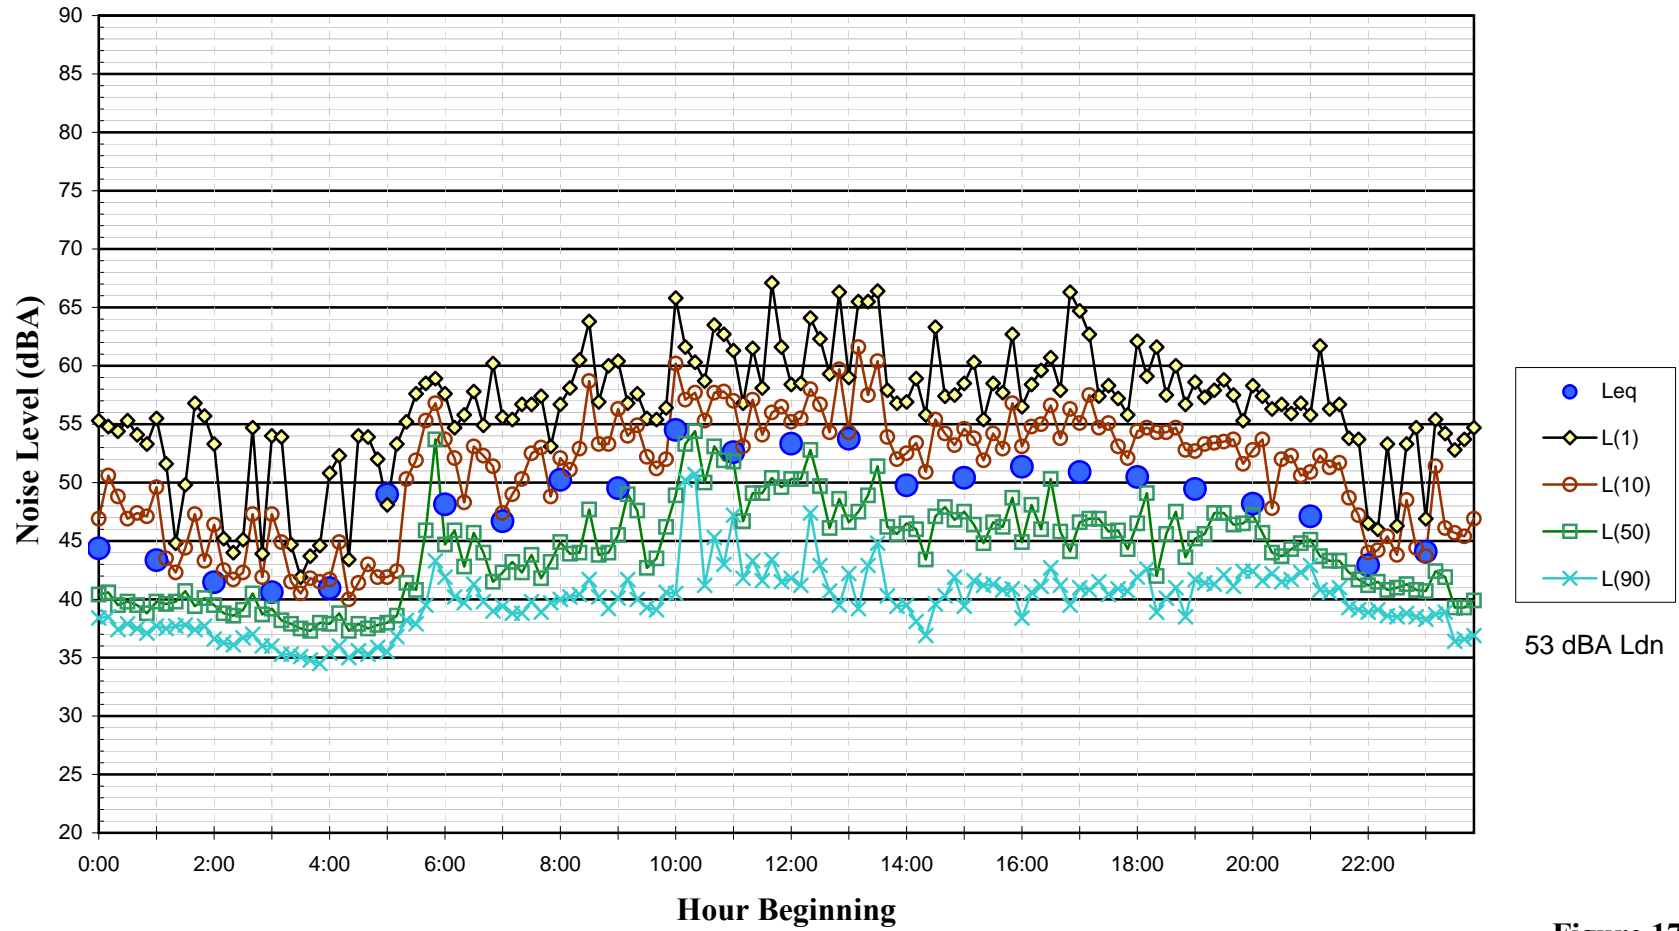
Figure 16

Noise Levels at LT-3
~ Lake Herman Quarry near Asphalt/Concrete Plants
Sunday, May 2, 2010

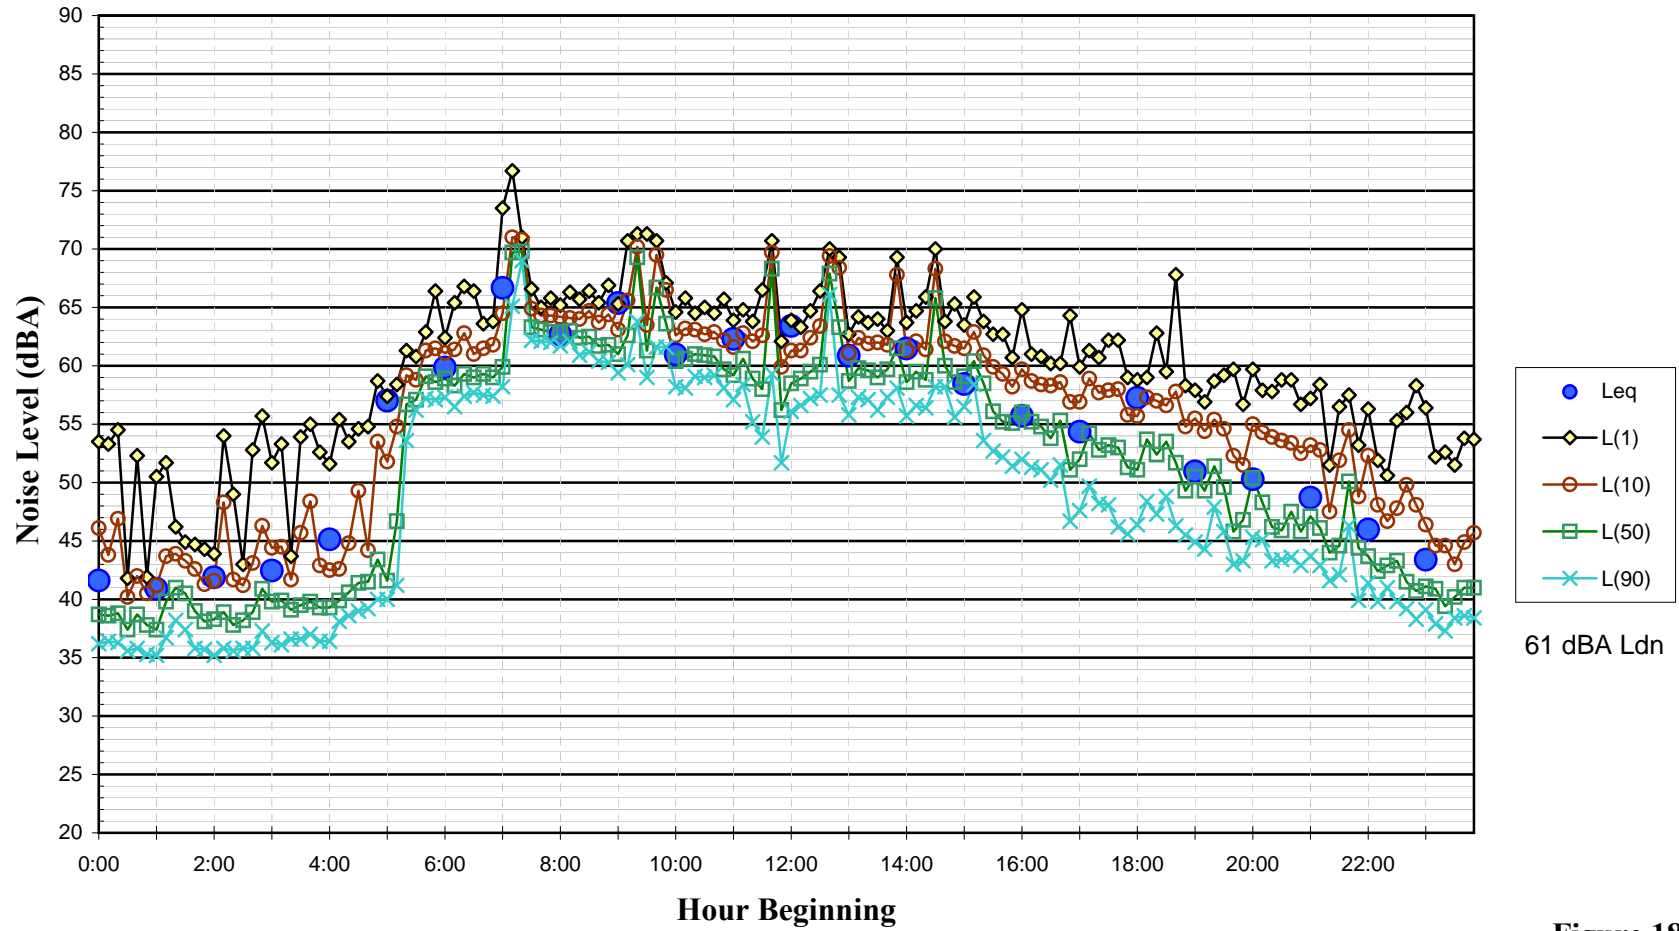
Figure 17

**Noise Levels at LT-3
~ Lake Herman Quarry near Asphalt/Concrete Plants
Monday, May 3, 2010**

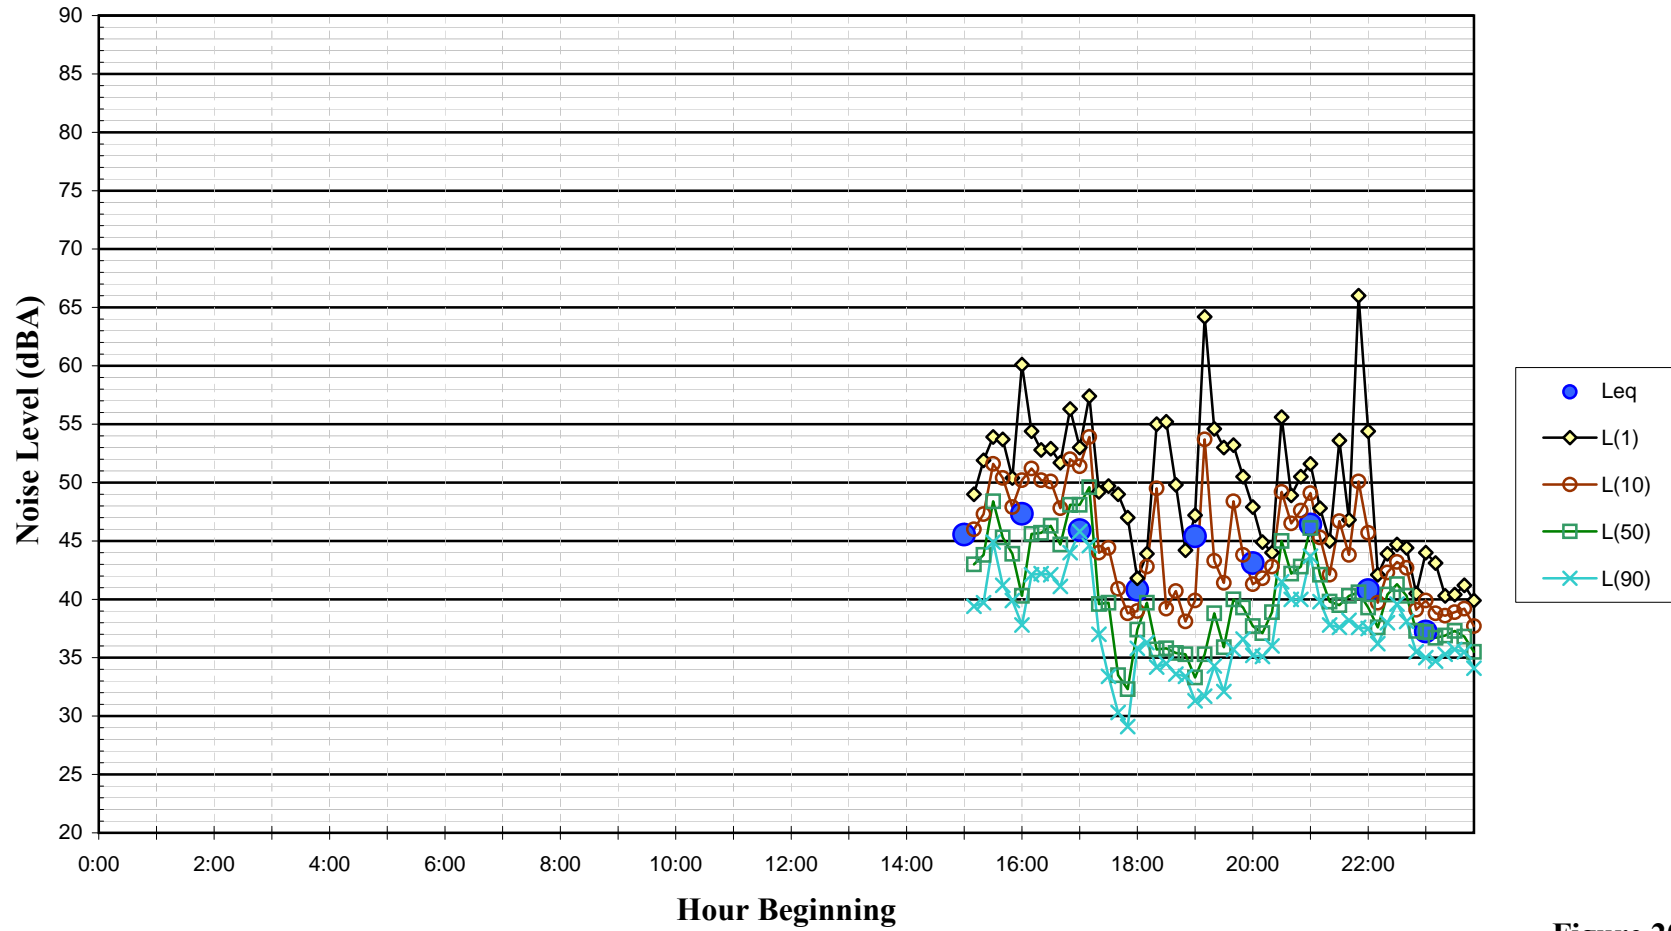
Figure 19

**Noise Levels at LT-4
~ End of St. John's Mine Road at McIntire Ranch
Thursday, April 29, 2010**

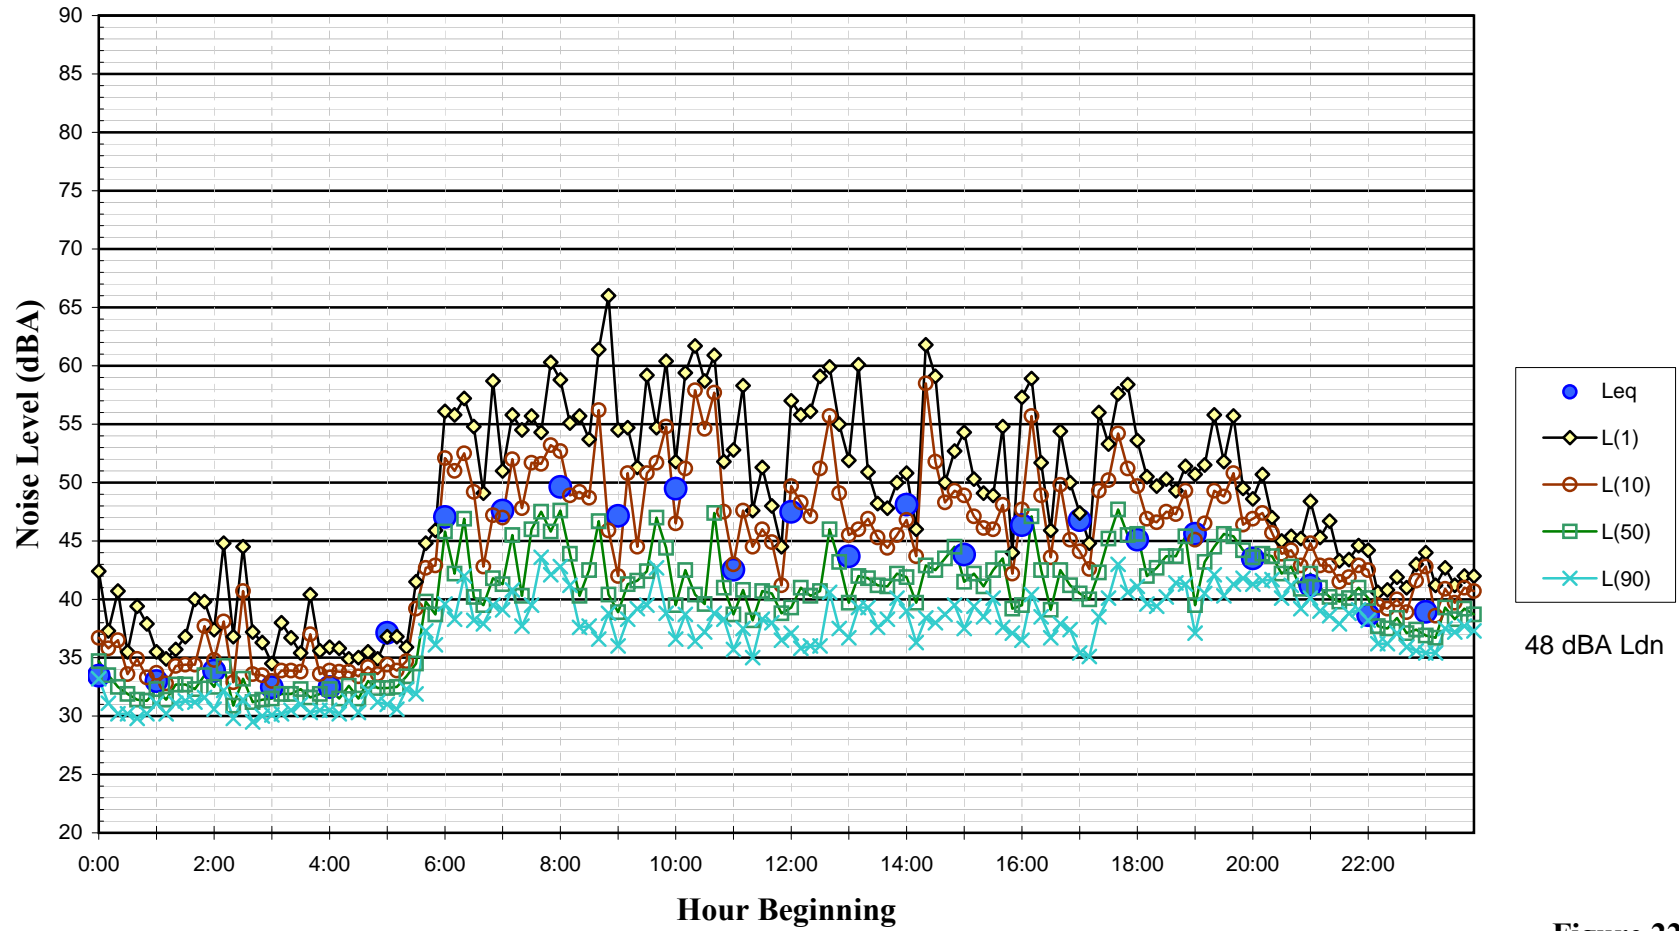
Figure 21

**Noise Levels at LT-4
~ End of St. John's Mine Road at McIntire Ranch
Saturday, May 1, 2010**

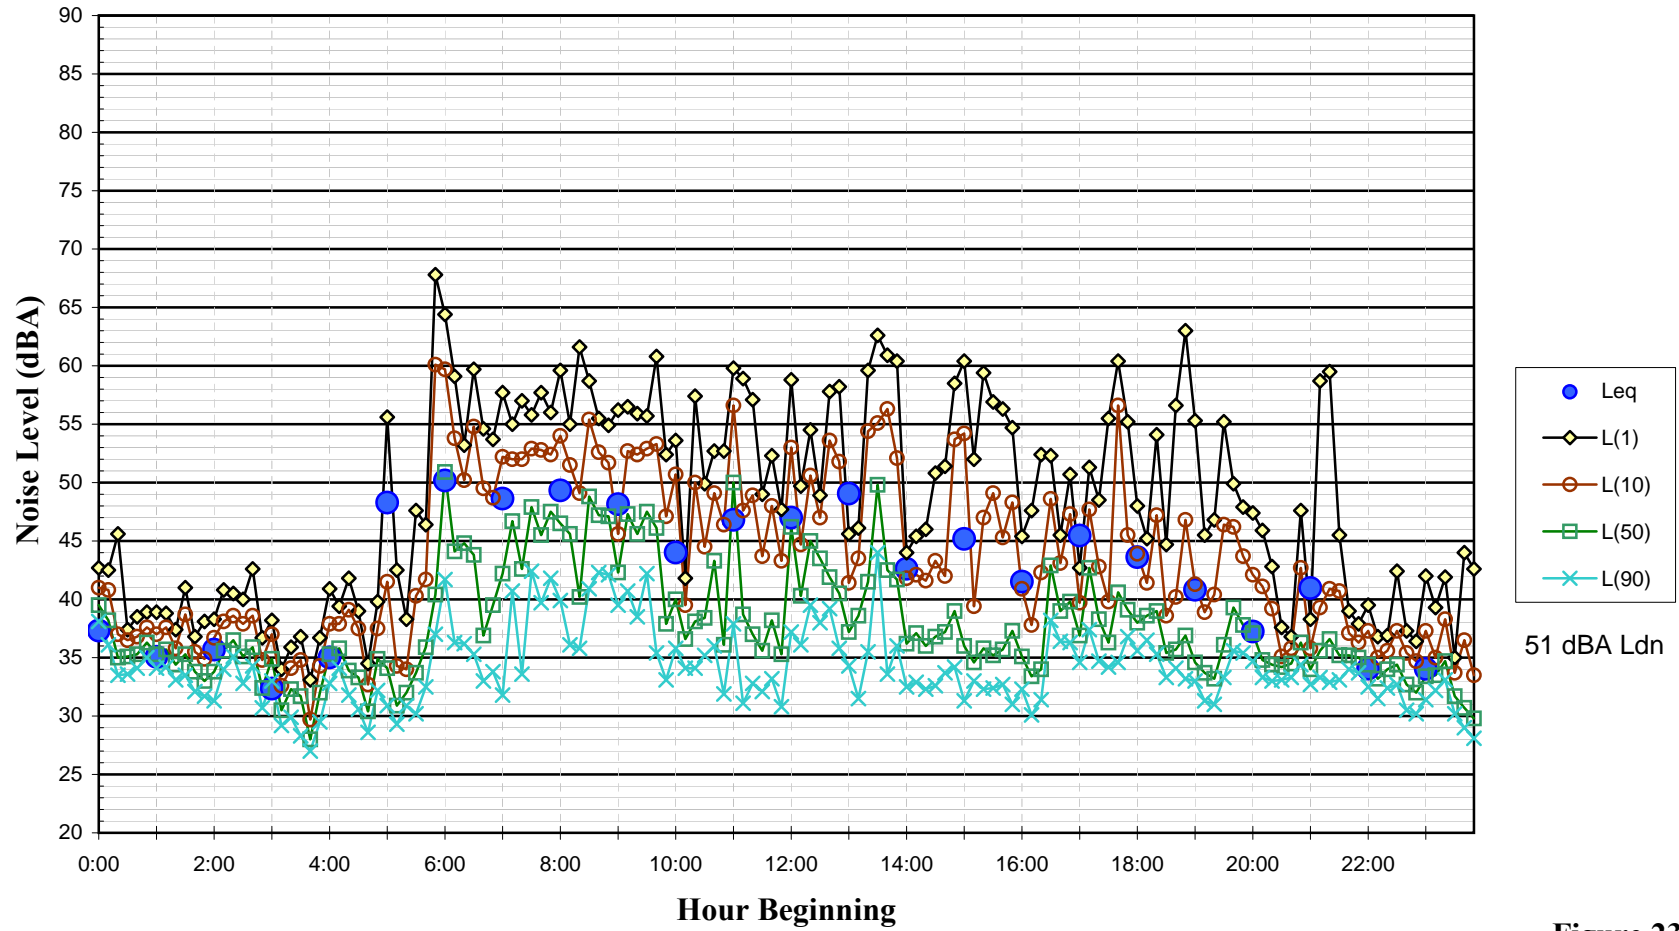
Figure 22

**Noise Levels at LT-4
~ End of St. John's Mine Road at McIntire Ranch
Sunday, May 2, 2010**

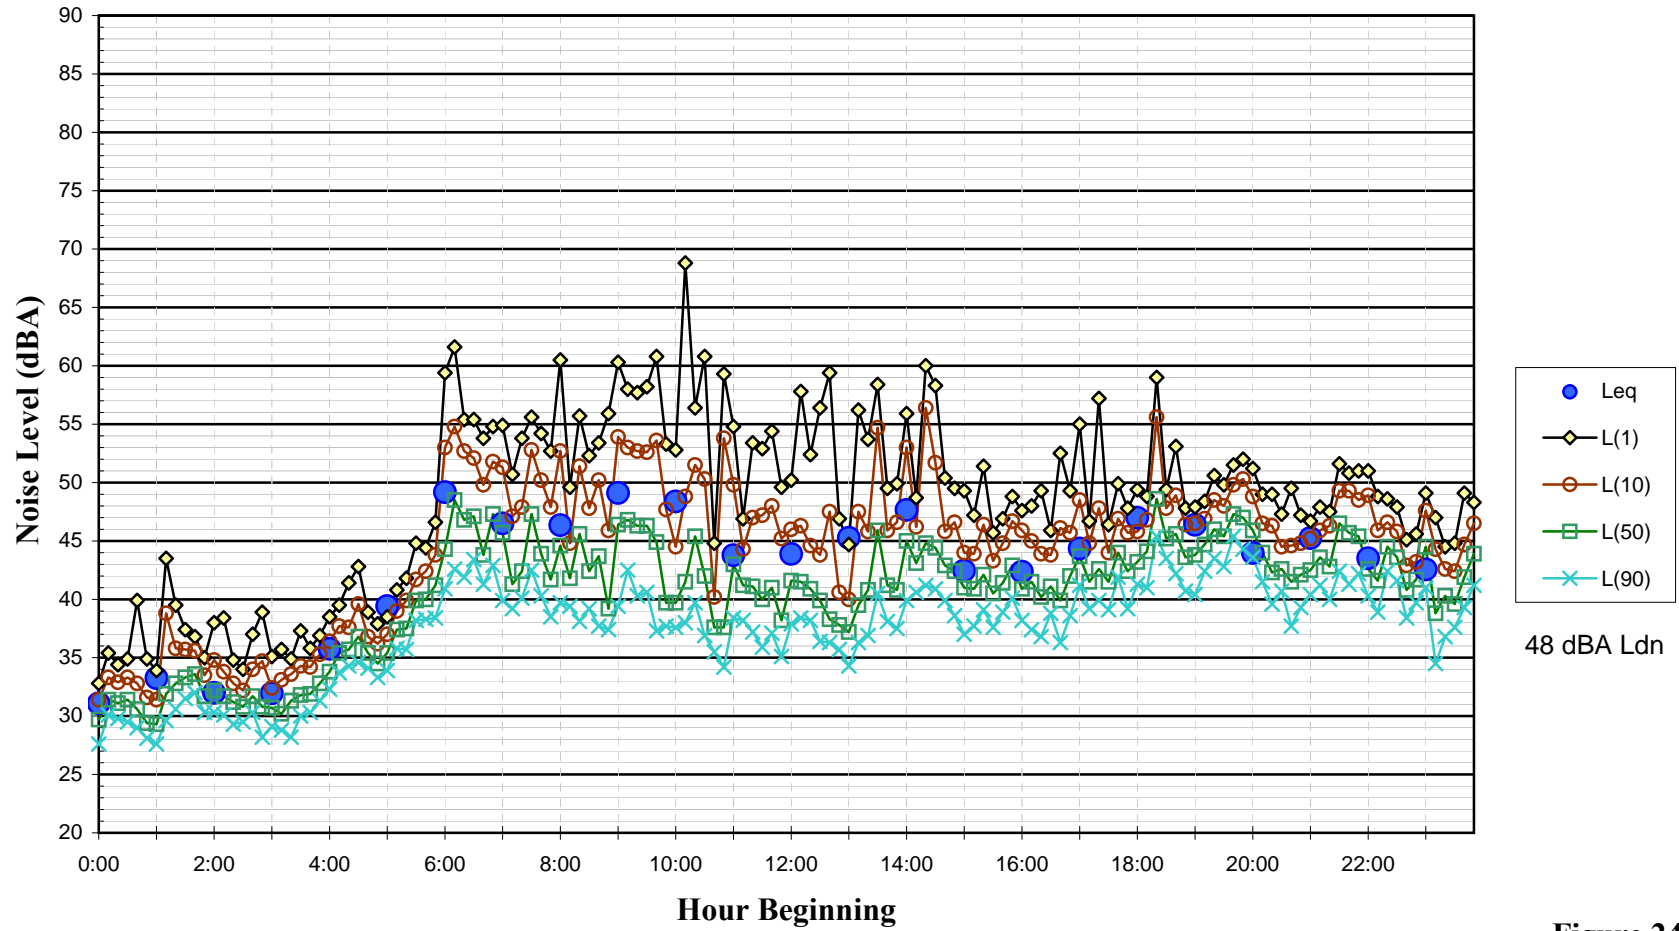
Figure 23

**Noise Levels at LT-4
~ End of St. John's Mine Road at McIntire Ranch
Monday, May 3, 2010**

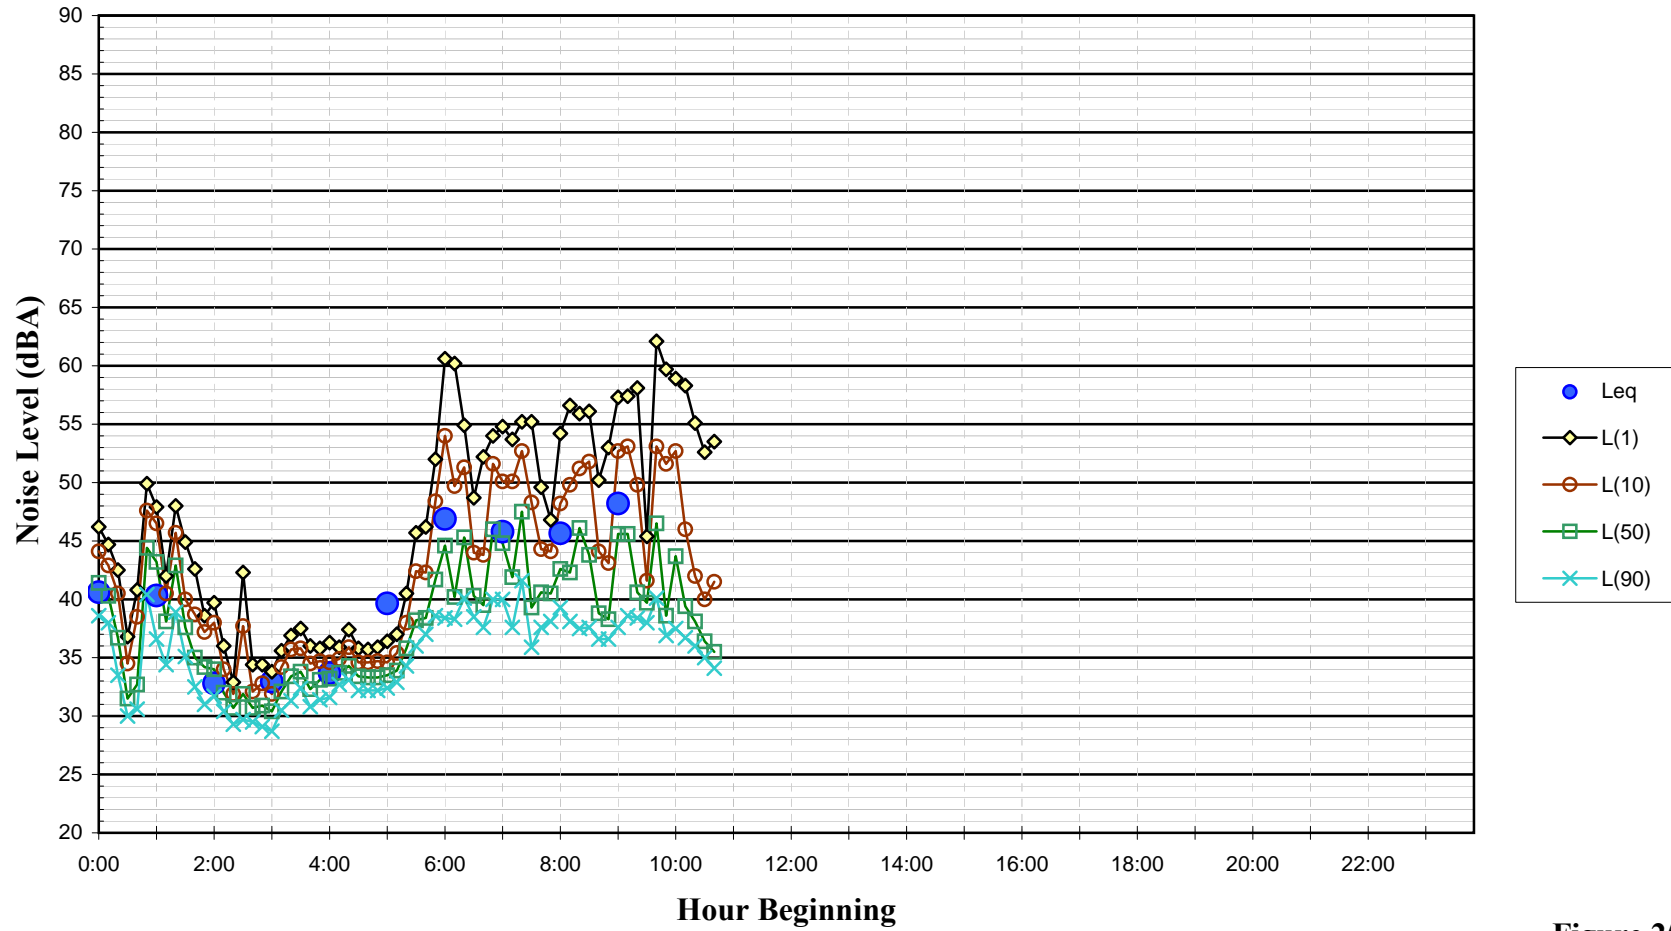
Figure 24

**Noise Levels at LT-4
~ End of St. John's Mine Road at McIntire Ranch
Tuesday, May 4, 2010**
