**Noise Levels at LT-1**  
**~ 420 feet from Center of Columbus Parkway, East of Turnberry Way Residences**  
**Thursday, April 29, 2010**

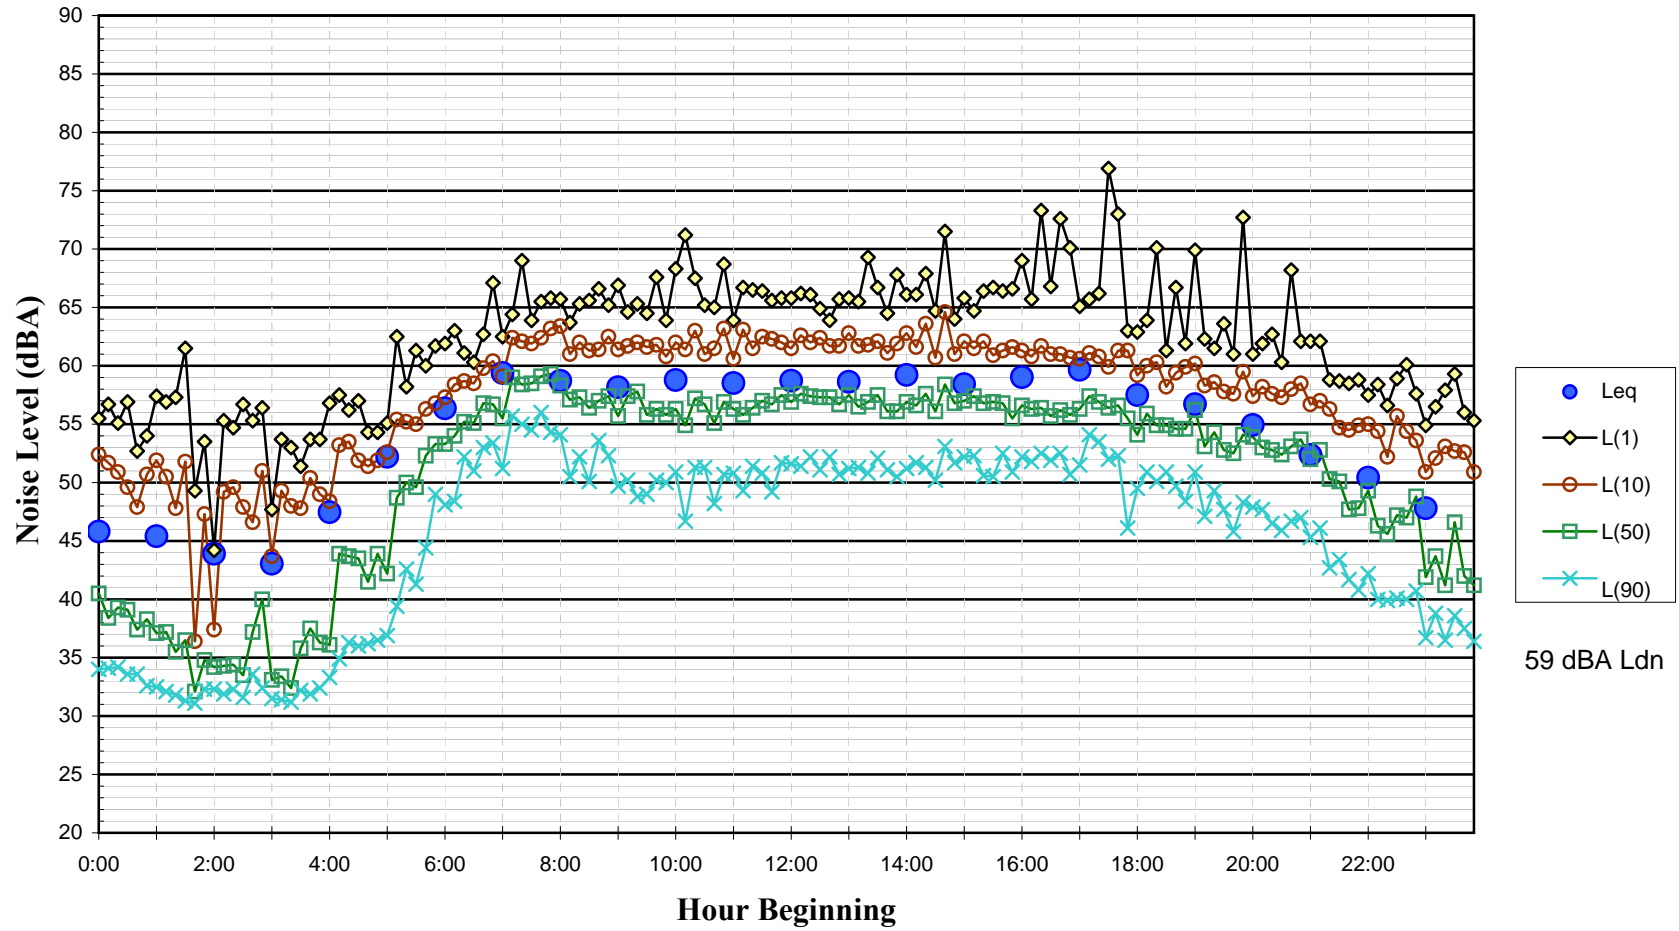
**Figure 5**

**Noise Levels at LT-1**  
**~ 420 feet from Center of Columbus Parkway, East of Turnberry Way Residences**  
**Monday, May 3, 2010**

59 dBA Ldn
