Noise Levels at LT-1
~ 420 feet from Center of Columbus Parkway, East of Turnberry Way Residences
Thursday, April 29, 2010

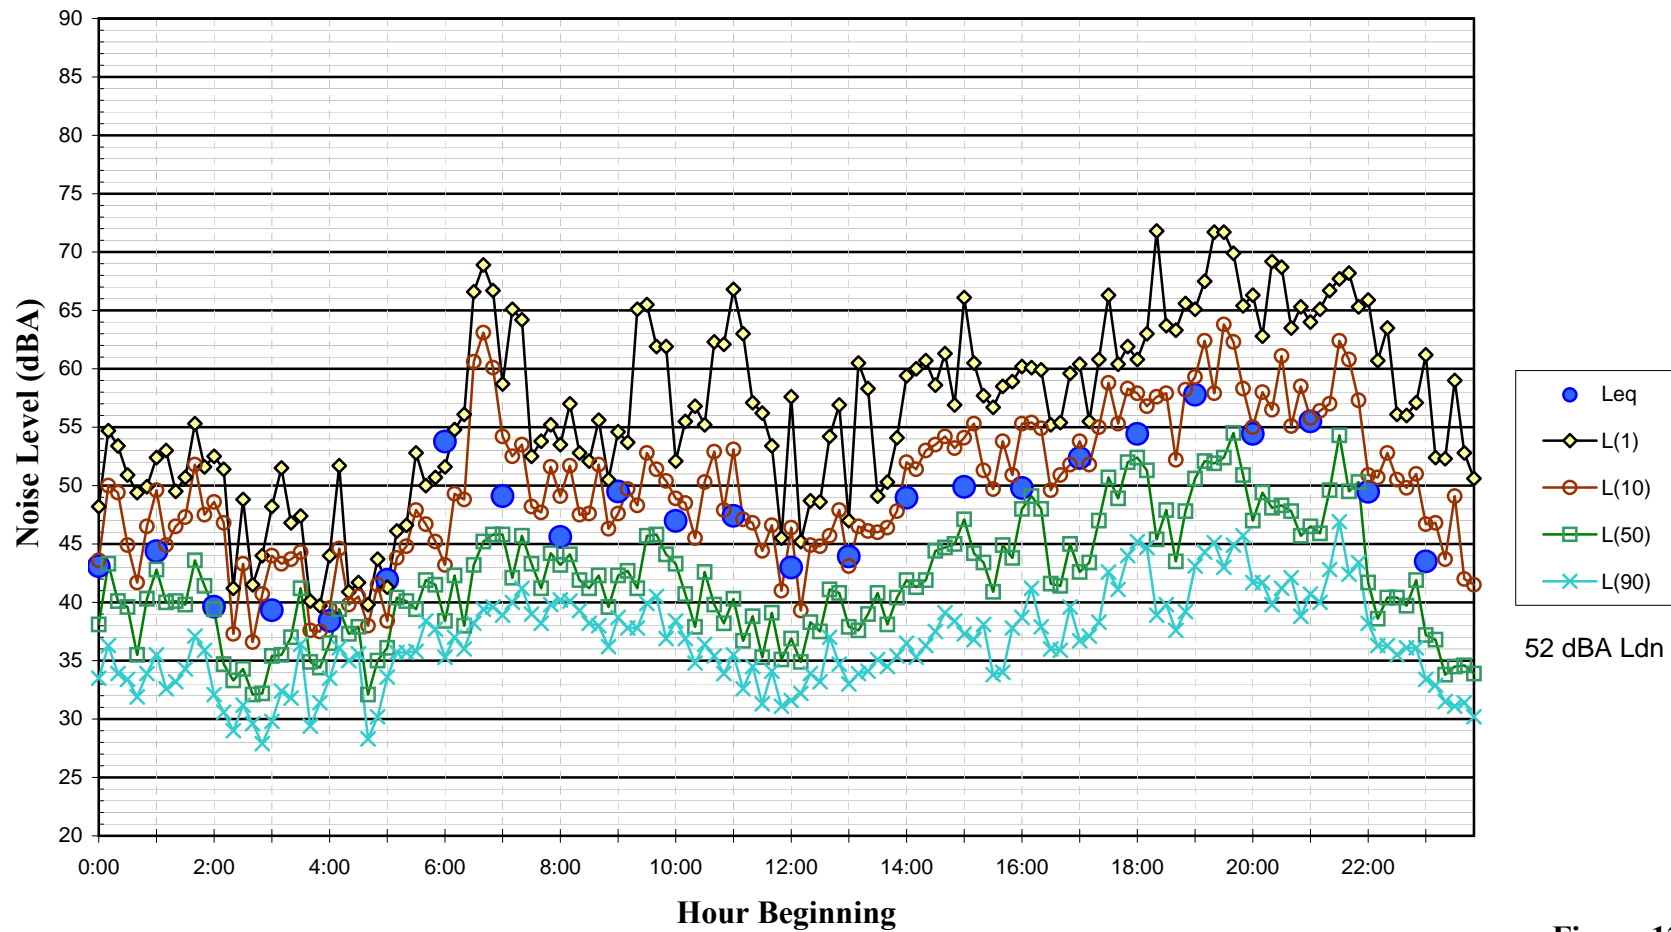
Figure 12

Noise Levels at LT-2
~ Sky Valley Lane, East of Lake Herman Quarry
Monday, May 3, 2010
