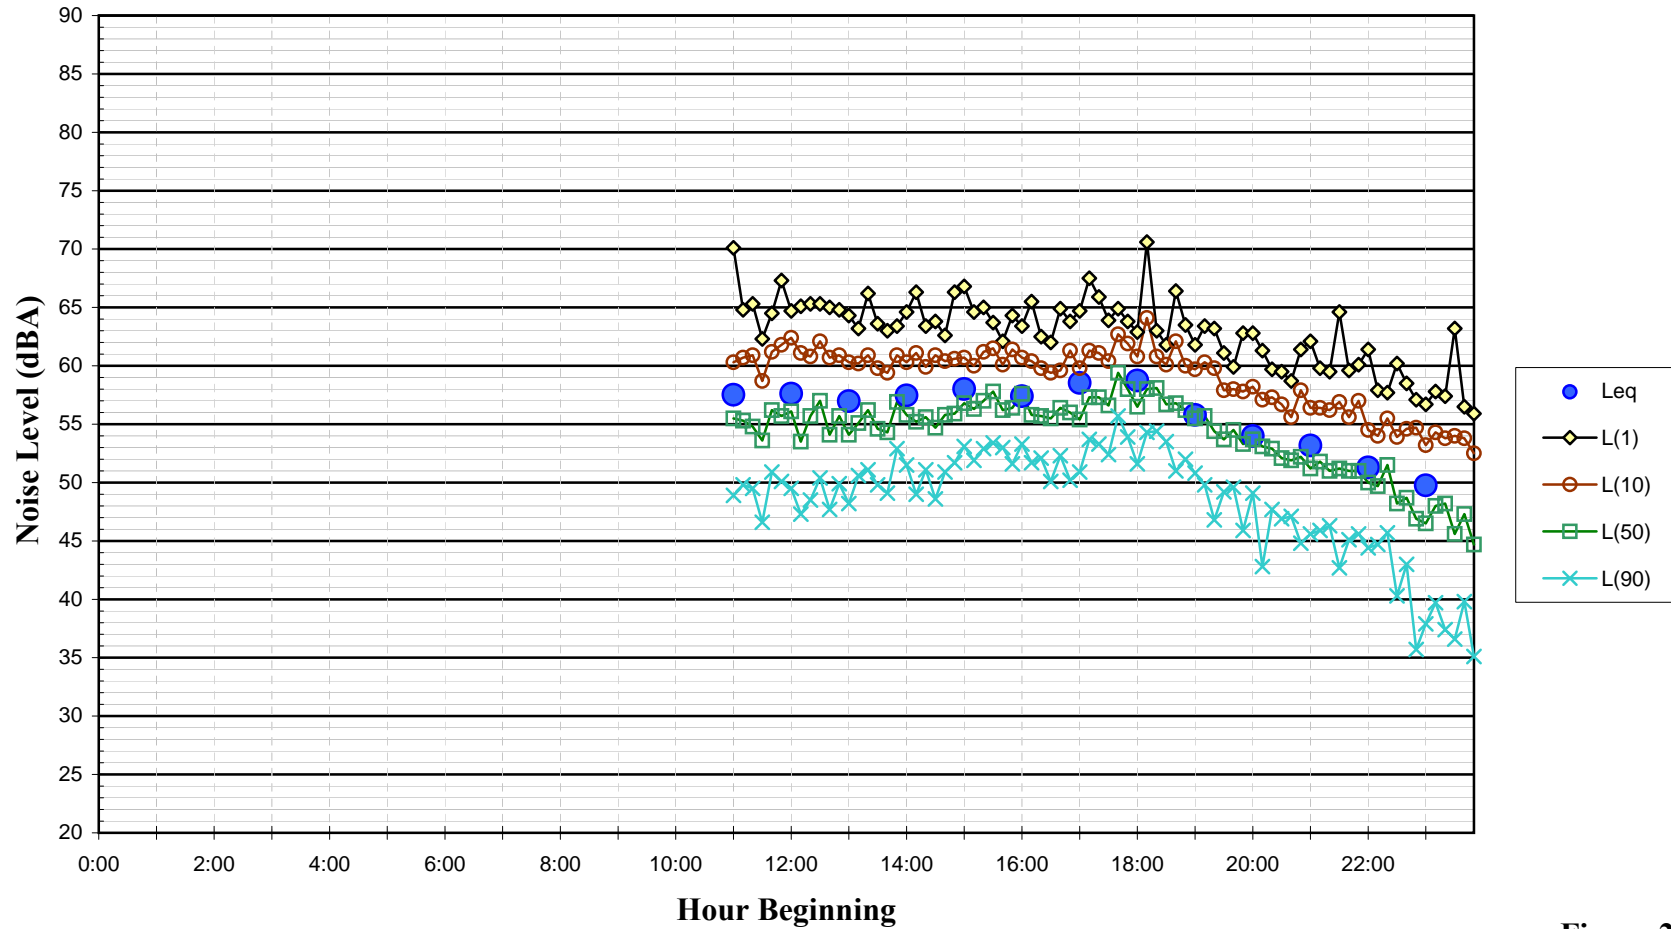
Noise Levels at LT-1
~ 420 feet from Center of Columbus Parkway, East of Turnberry Way Residences
Thursday, April 29, 2010

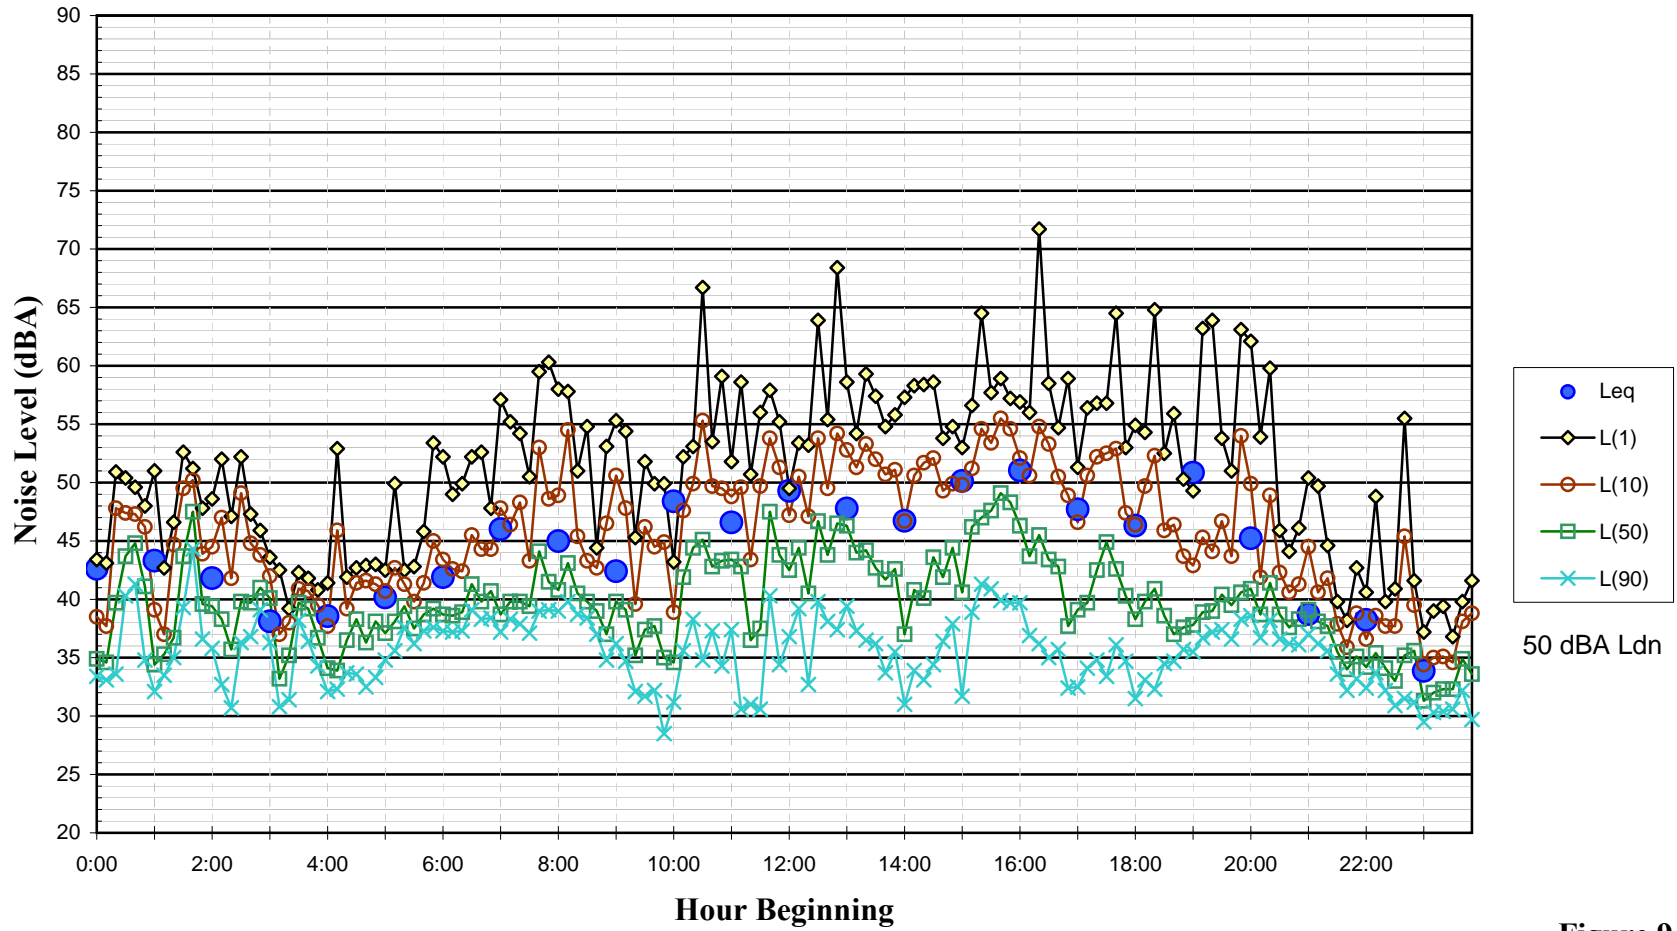
Figure 8

Noise Levels at LT-2
~ Sky Valley Lane, East of Lake Herman Quarry
Friday, April 30, 2010

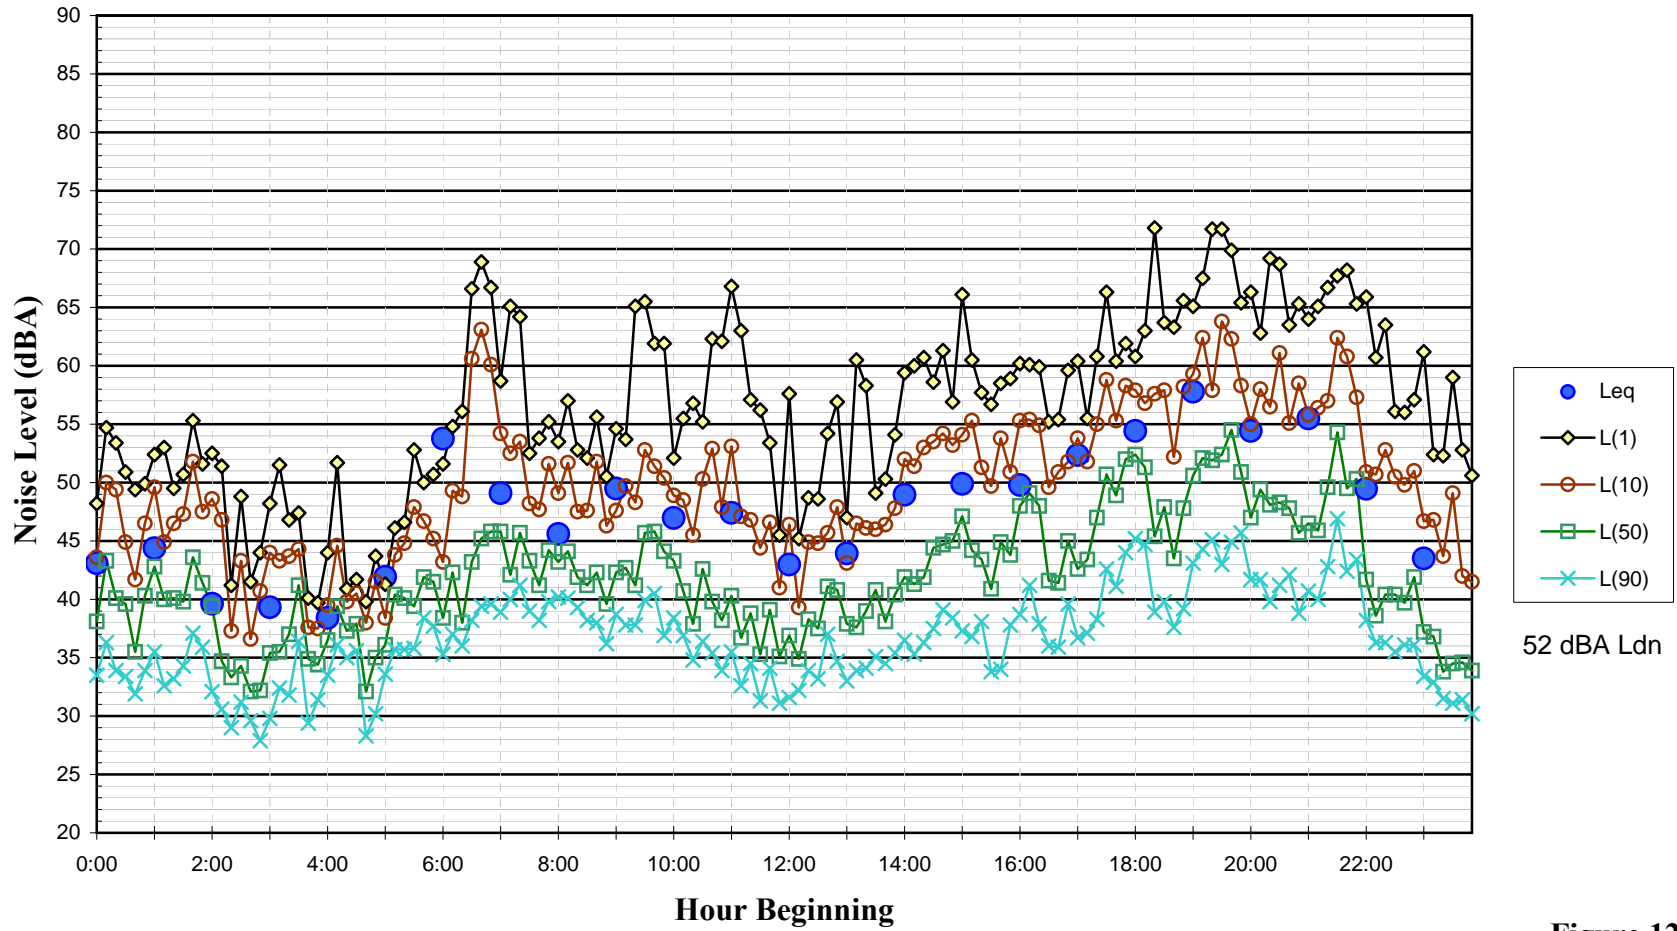
Figure 11

Noise Levels at LT-2
~ Sky Valley Lane, East of Lake Herman Quarry
Monday, May 3, 2010

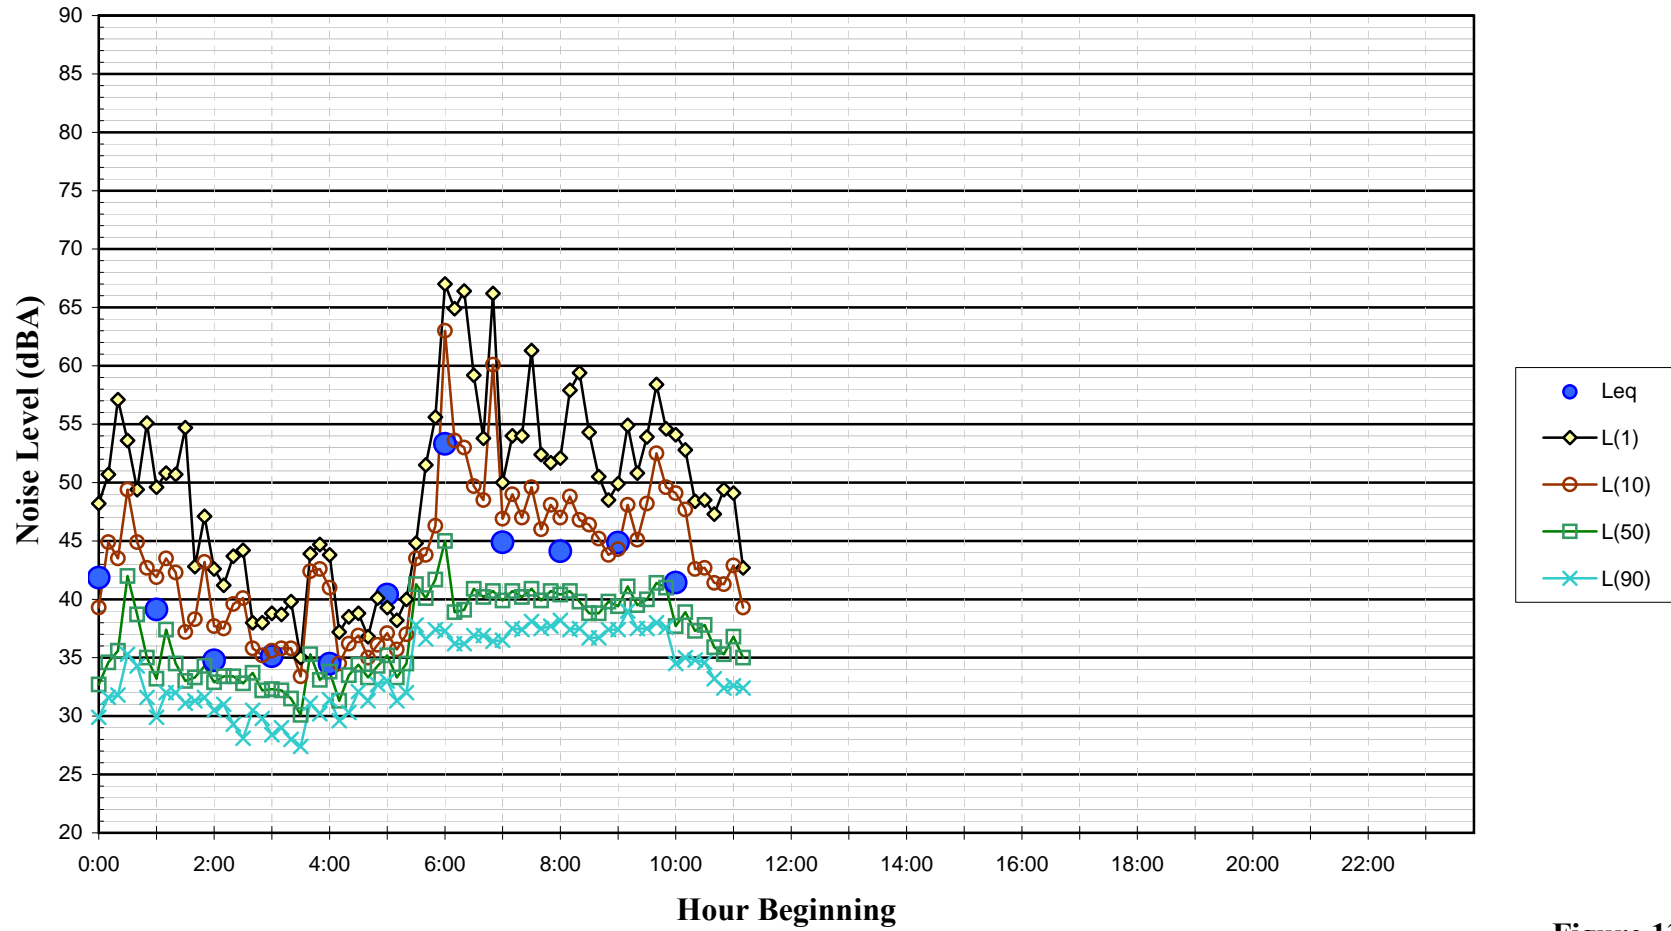
Figure 12

Noise Levels at LT-2
~ Sky Valley Lane, East of Lake Herman Quarry
Tuesday, May 4, 2010

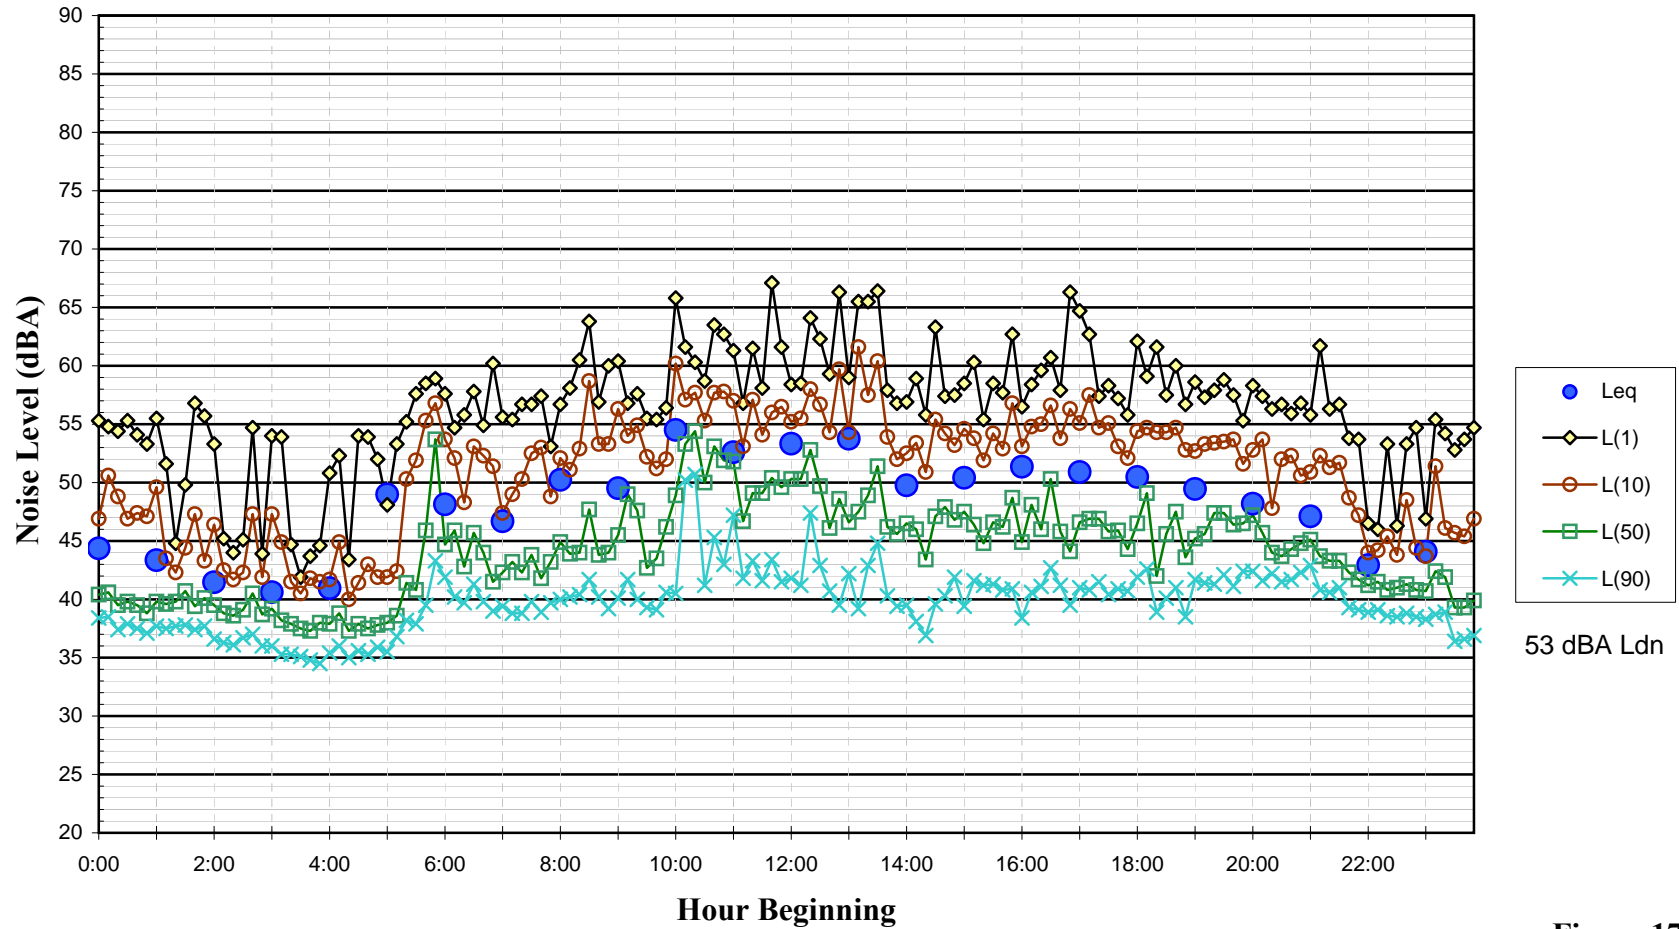
Figure 16

**Noise Levels at LT-3
~ Lake Herman Quarry near Asphalt/Concrete Plants
Sunday, May 2, 2010**

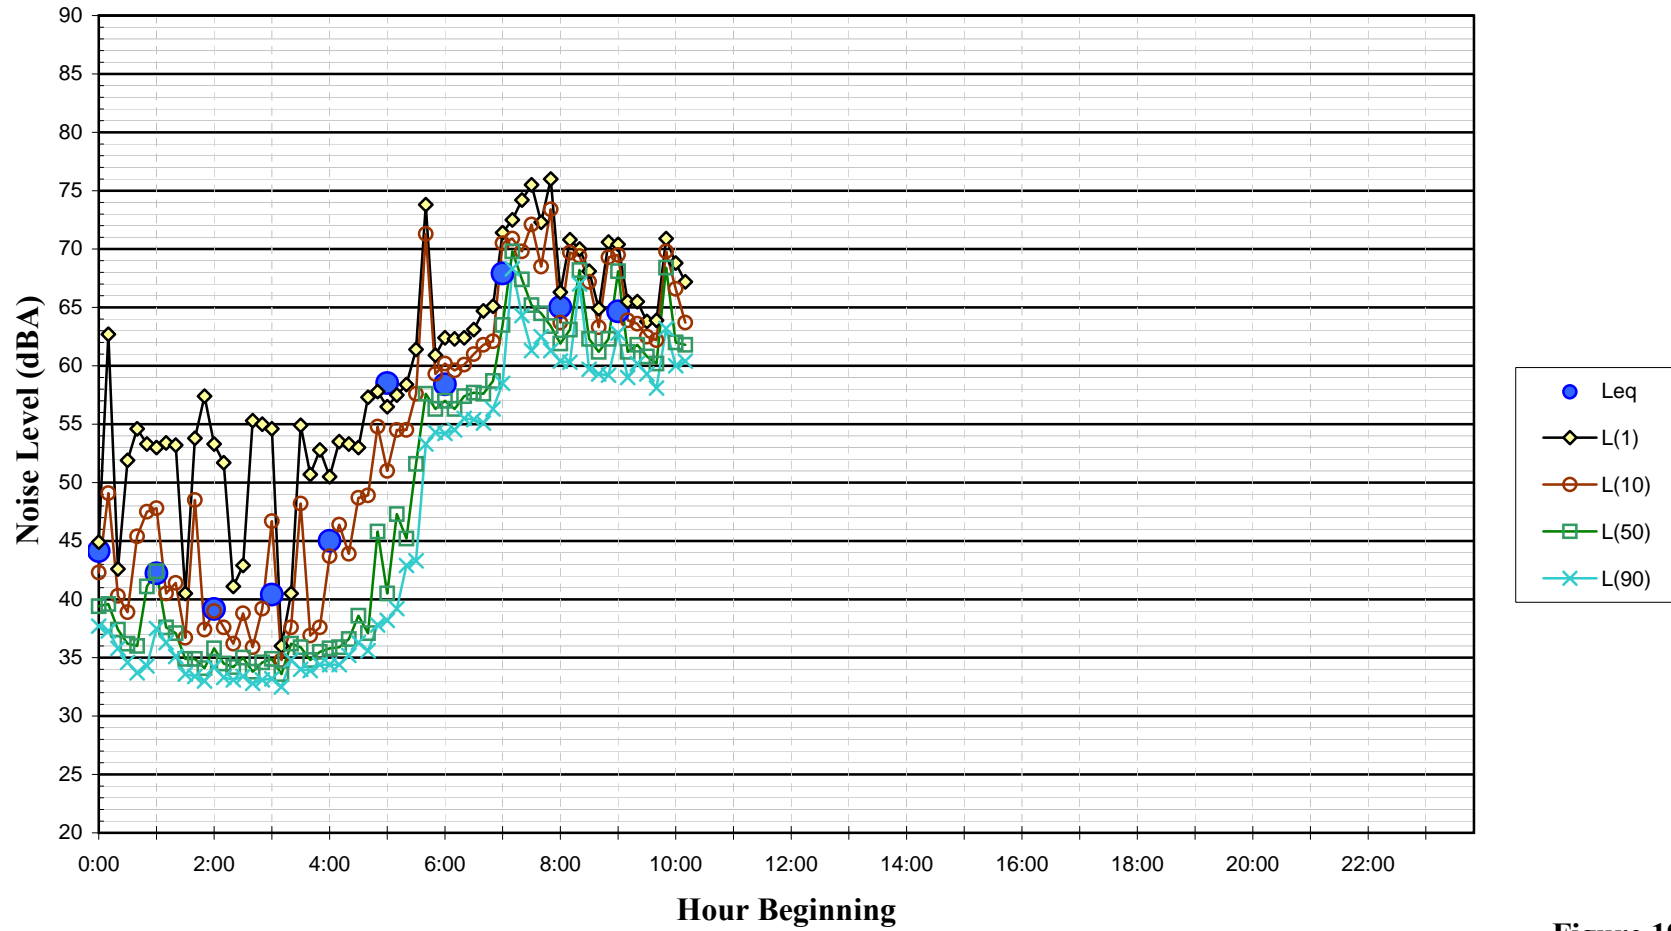
Figure 18

Noise Levels at LT-3
~ Lake Herman Quarry near Asphalt/Concrete Plants
Tuesday, May 4, 2010

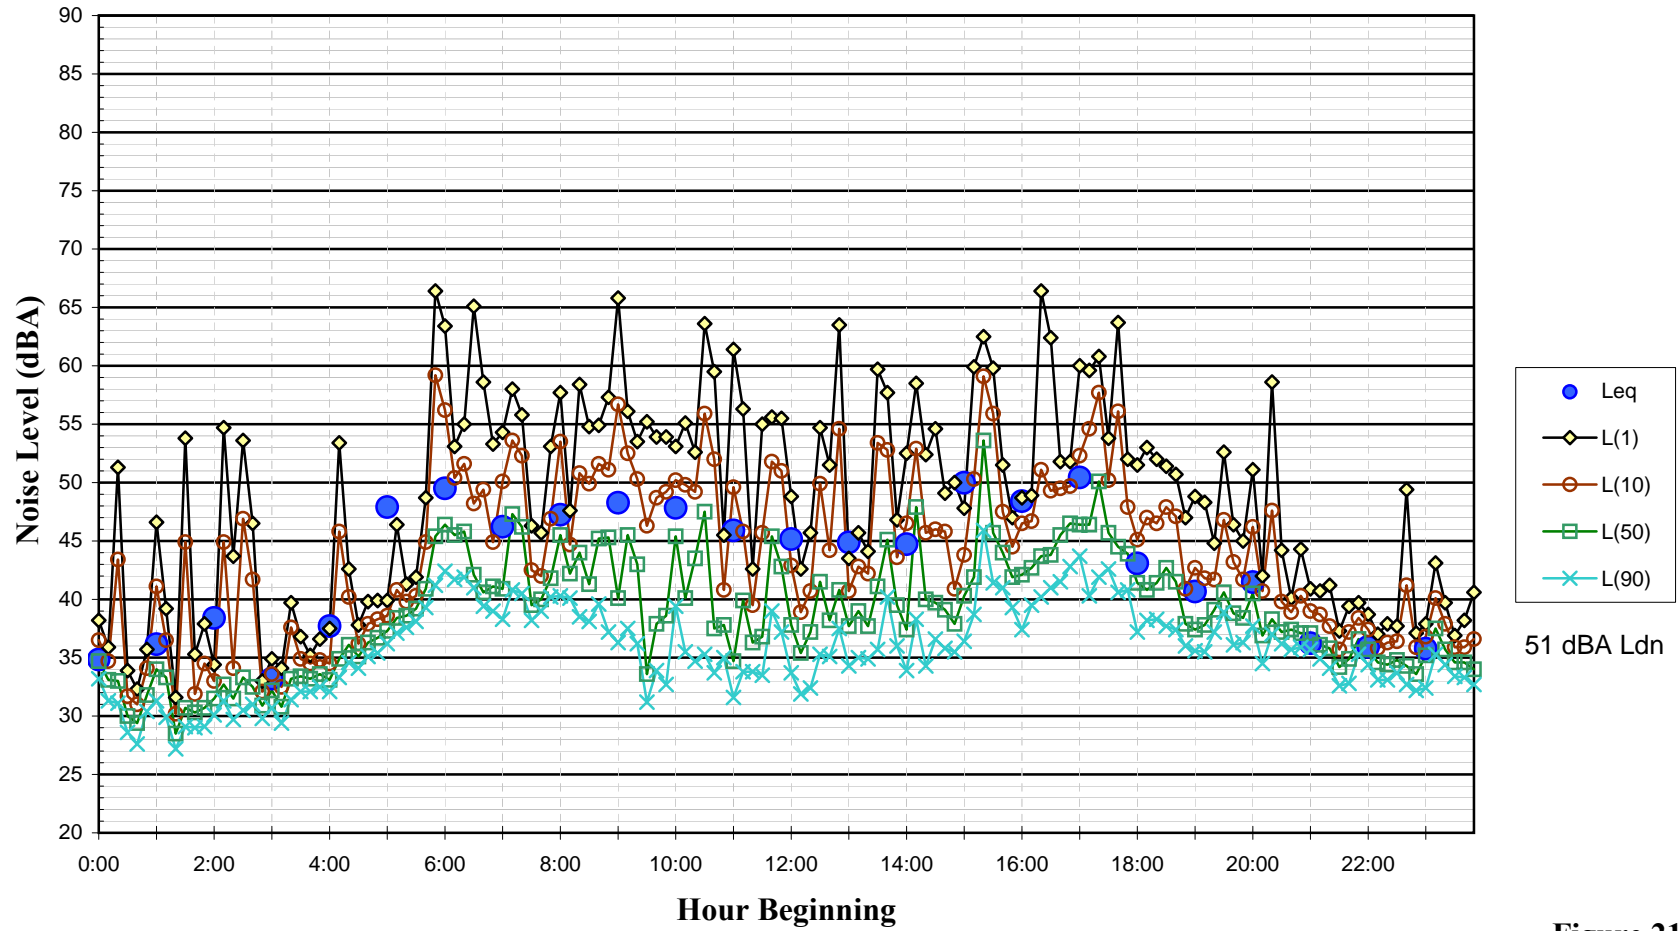
Figure 20

**Noise Levels at LT-4
~ End of St. John's Mine Road at McIntire Ranch
Friday, April 30, 2010**
