**Pre-Construction
Meteorological Tower Fatality Study
at the
Hamilton Ranch Wind Power Project
Solano County, California**

Final Report

May 2008

Prepared by:
CURRY & KERLINGER, L.L.C.

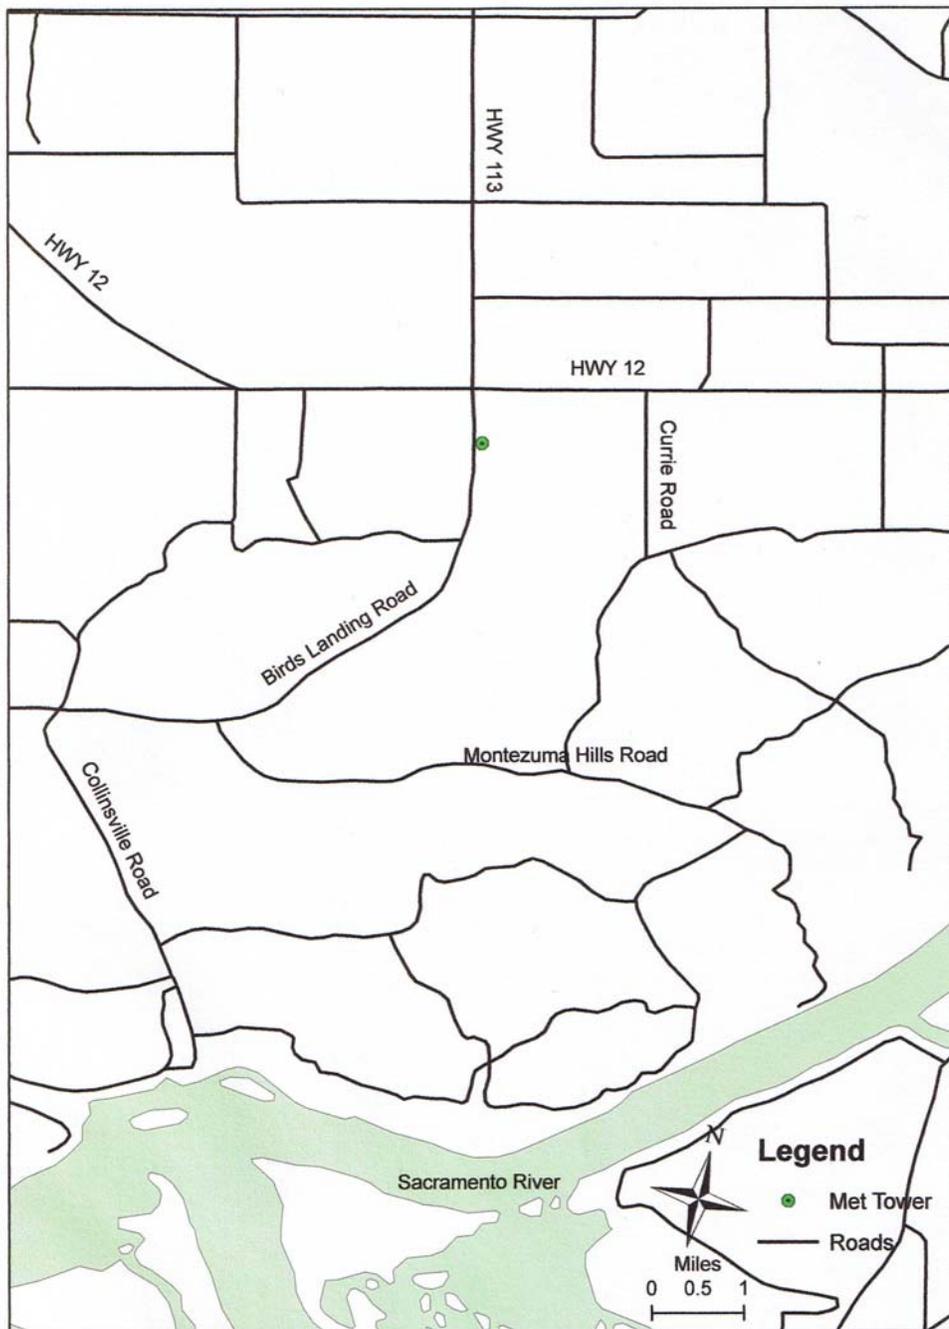
One temporary meteorological tower, operated by FPL Energy, is installed at the Hamilton Ranch Wind Power Project area (Figure 1). The temporary meteorological tower was searched once per week for carcasses, between February 6 and April 29, 2008. Prior to standardized carcass surveys, on January 30, 2007, a clean sweep survey was conducted at the tower to remove any carcasses present prior to the study. A total of 63 individual standardized met tower searches were conducted during this 15 month study.

Figure 1. Locations of 1 temporary meteorological tower in the Hamilton Ranch Project Area, Solano County, California, surveyed February 2007 – April 2008.

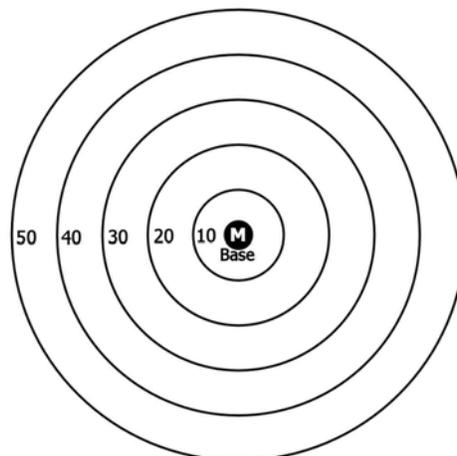
The survey consists of searchers walking in concentric circles around the met tower’s base at distances of 10, 20, 30, 40, and 50 meters, and also around the base of each tower (Figure 2). While walking around each ring, the searcher using the unaided eye, alternately scans an area that extends for 5m in either side of his track, yielding a total of 55 meters scanned. The surveyors use range finders to initially establish and periodically check the distance of each circular route from the tower. Data recorded at the beginning of the surveys includes meteorological data (cloud cover, temperature, and wind velocity) and ground cover information (crop type and height). In addition, the start and finish times are recorded for each tower searched (see Appendix A).

Figure 2. Search pattern for meteorological tower carcass survey (distance in meters)

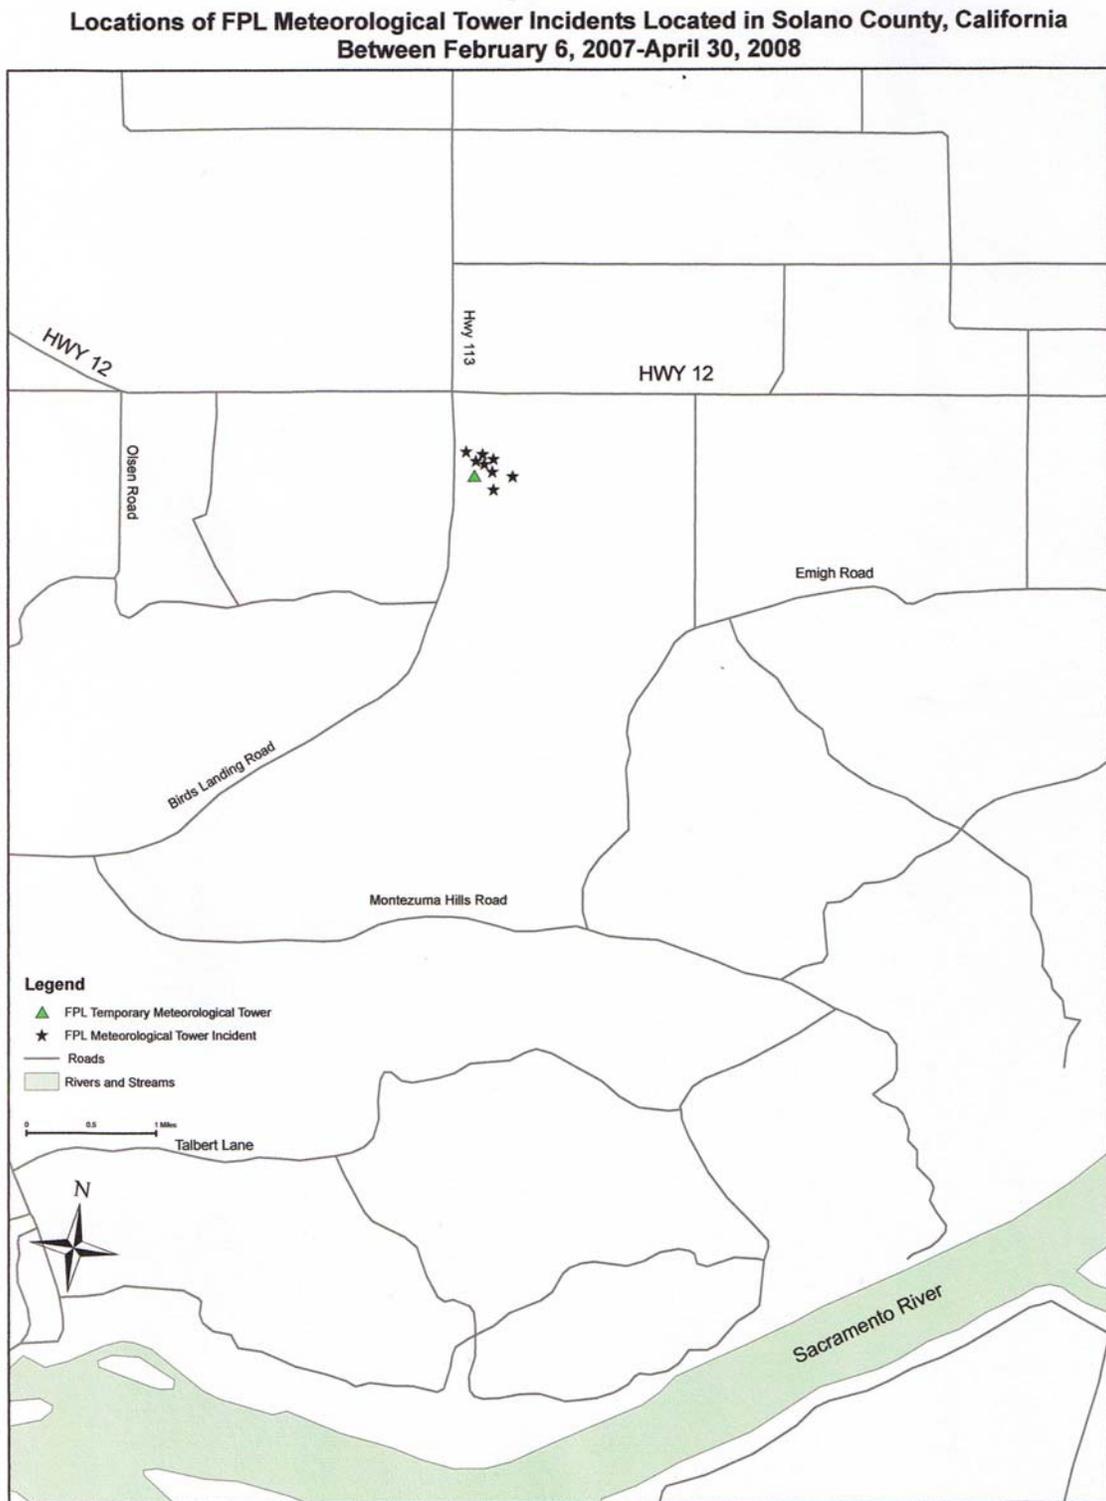
The locations of all 8 incidents found during standardized surveys at the Hamilton met tower are shown in Figure 3.

Figure 3. Locations of 8 incidents found during standardized surveys at the Hamilton Ranch met tower, February 6, 2007 through April 29, 2008.

Of the 8 incidents found during standardized surveys, 75% were located between 21 and 40 meters of the met tower (Table 7). All incidents found were medium sized carcasses. One incident was found between 11 and 20 meters, and one (the most distant) was found at 41 meters. With such a small sample size of incidents, it is tentative to speculate on a pattern of carcass locations, however the 50 meter survey area appears to be sufficient for finding all carcasses.

Compass bearing was recorded for all incidents from tower to carcass (see Appendix C for individual incident bearings given in degrees geographic north), and is likely to correspond roughly to wind direction. While the wind direction recorded during surveys may not accurately represent the direction of the wind blowing at the moment of the incident, wind direction is in general somewhat seasonal and similar from one day to the next. Seventy-five percent (75%) of incidents (Table 8) were found north to east of the met towers, while wind direction for 61% of surveys where wind direction was recorded, was from the opposite direction, from the south to west southwest.
